# Access Compliance Report

## Public Rights-of-Way

### (Curb Ramps)

Intersection ID: 50607	Main Street: DENBUR_DR	Cross Street: STREAM_ORCHID_LN	Location: NW
ADA ID: 46378844A964	Ramp Type: Perp	Initial Pass/Fail: Fail	Overall Compliance: No
Severity Score: 22.5			
Codes/Mitigation Info/Possible Solution		Field Measurements/Component Compliance

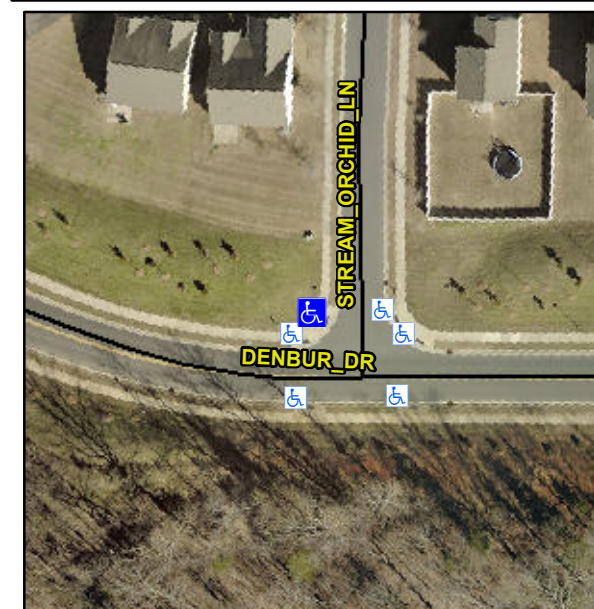
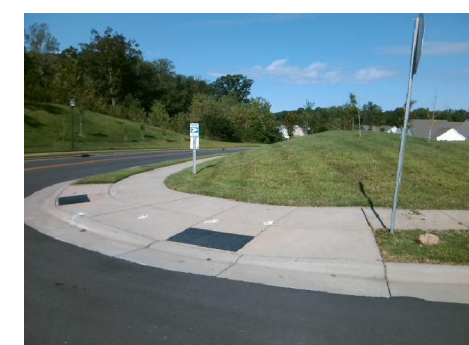
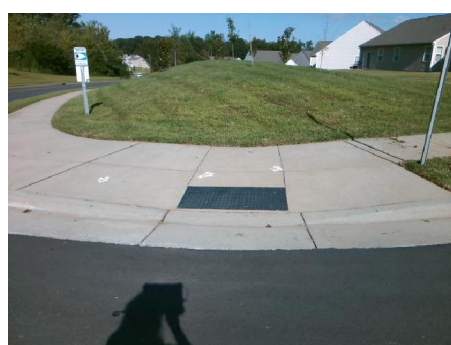
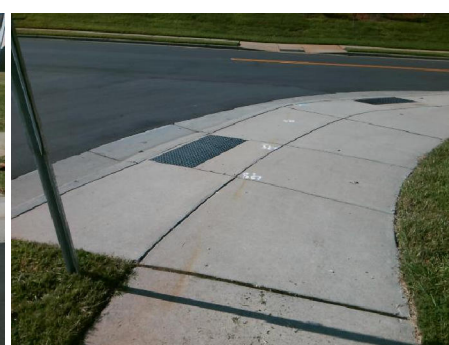
**Not Found, R304.5.1, R304.2.2, R304.5.3**

Compliance	Description	Data	Compliance	Description	Data
N/A	Ramp Length (in)	47.5	No	Ramp Slope (%)	8.4
No	Ramp Width (in)	47.5	No	Ramp XSlope (%)	2.7
N/A	Flare Type LT	N/A	N/A	Flare Type RT	N/A
N/A	Flare Slope LT (%)	N/A	N/A	Flare Slope RT (%)	N/A
N/A	Flare Traversable LT?	N/A	N/A	Flare Traversable RT?	N/A
N/A	Landing Length (in)	N/A	N/A	DWS Provided?	N/A
N/A	Landing Width (in)	N/A	N/A	DWS Contrast?	N/A
N/A	Landing Slope (%)	N/A	N/A	DWS Length (in)	N/A
N/A	Landing X Slope (%)	N/A	N/A	DWS Full Width?	N/A
N/A	Landing Curb? (Y/N)	N/A	N/A	DWS Offset (in)	N/A
N/A	Shared Landing?	N/A			
N/A	Gutter Ponding?	N/A	N/A	Gutter Slope (%)	N/A
N/A	Gutter Lip Ht (in)	N/A	N/A	Gutter X Slope (%)	N/A
N/A	Painted X Walk1?	No	N/A	Painted X Walk2?	N/A
	X Walk 1 Direction	To E		X Walk 2 Direction	N/A
N/A	X Walk 1 Width (in)	N/A	N/A	X Walk 2 Width (in)	N/A
	X Walk 1 Slope (%)	4.5		X Walk 2 Slope (%)	N/A
	X Walk 1 X Slope (%)	2.2		X Walk 2 X Slope (%)	N/A

**Remove & Replace Entire Ramp.**
