# Access Compliance Report

## Public Rights-of-Way

### (Curb Ramps)

Intersection ID: 31368	Main Street: GREENWAY_VISTA_LN	Cross Street: LINDA_VISTA_LN	Location: W
ADA ID: 46540F780ACE	Ramp Type: BlendTrans1	Initial Pass/Fail: Fail	Overall Compliance: No
		Severity Score: 15

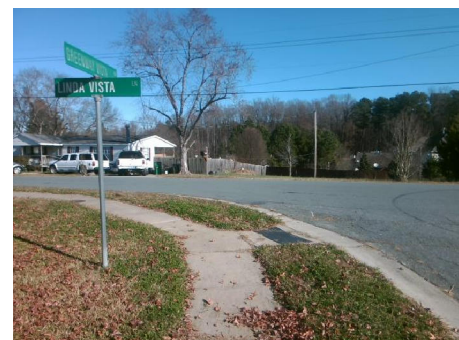
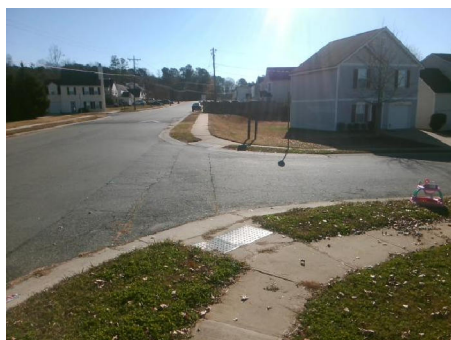
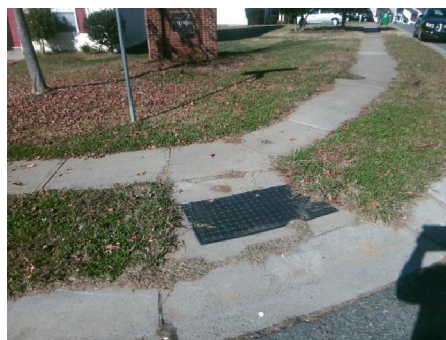
**Not Found, R302.7**

N/A	Ramp inside XWalk1?	N/A	N/A	Ramp inside XWalk2?	N/A
	Road Slope (%)	1.8		Clear Space?	N/A
	Road X Slope (%)	2.0	N/A	Clear Space to XWalk (in)	N/A
N/A	Any Obstructions?	N/A	N/A	Storm Grate/Utility Hazard?	N/A
	Obstruction Type			Storm Grate/Utility Type	
		N/A			N/A
			No	Surface Condition? (G/P)	Poor
			No	Curb Slope (%)	7.3

**Remove & Replace Curb Ramp With Two New Directional Ramps or Equivalent.**
