Access Compliance Report

Public Rights-of-Way

| Intersection ID: 3595 | Main Street: CLAIBORNE_WOODS_RD | Cross Street: TARPAN_CT | Location: | N |
| ADA ID: 468452C23C58 | Ramp Type: BlendTrans2 | Initial Pass/Fail: Fail | Overall Compliance: No | Severity Score: 1.25 |

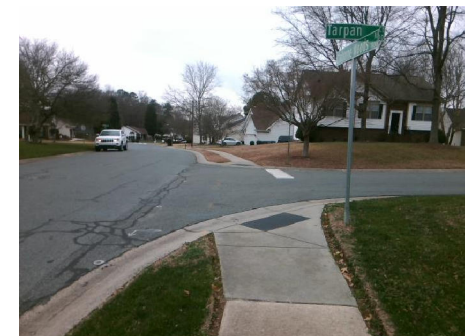
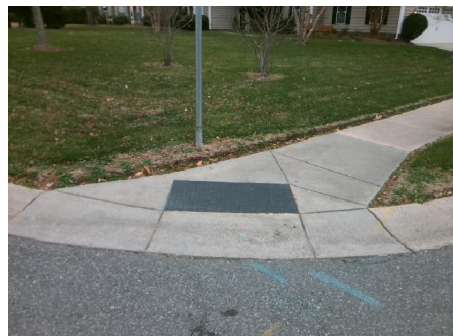
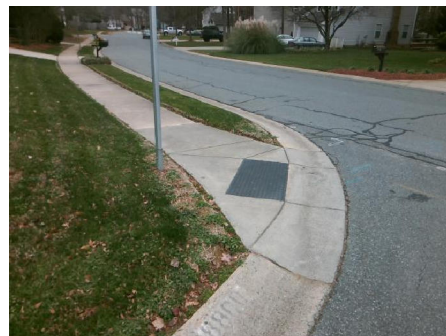
Not Found, R304.5.3

| Compliance | Description | Data | Compliance | Description | Data |
|---|---|---|---|---|---|
| Yes | Ramp Width (in) | 48.0 | No | BlendTrans XSlope (%) | 3.5 |
| | | | No | Curb Slope (%) | 7.8 |

Remove & Replace Curb Ramp With Two New Directional Ramps or Equivalent.
