Access Compliance Report

Public Rights-of-Way

(Curb Ramps)

Intersection ID: 48304	Main Street: FAZENDA_DR	Cross Street: GANSO_LN	Location: NW
ADA ID: 46B88010A4A9	Ramp Type: PerpDiag	Initial Pass/Fail: Fail	Overall Compliance: No
Severity Score: 8.75			
Codes/Mitigation Info/Possible Solution		Field Measurements/Component Compliance

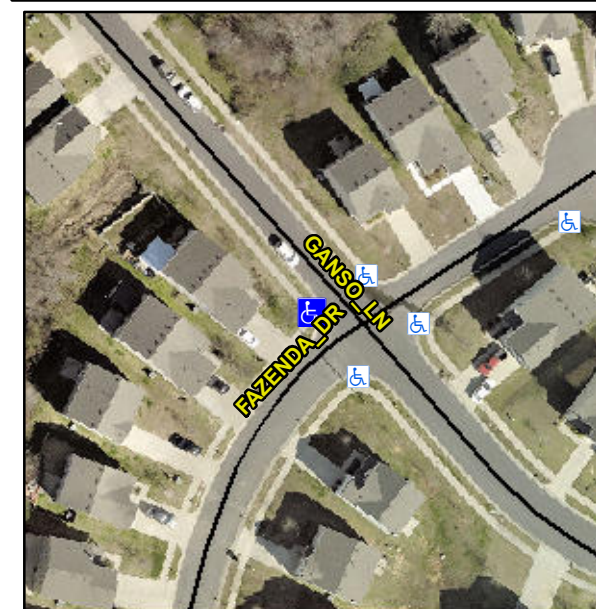
Not Found, R304.5.1

Compliance	Description	Data	Compliance	Description	Data
N/A	Ramp Length (in)	48.0	Yes	Ramp Slope (%)	8.0
No	Ramp Width (in)	47.0	Yes	Ramp XSlope (%)	1.3
N/A	Flare Type LT	N/A	N/A	Flare Type RT	N/A
N/A	Flare Slope LT (%)	N/A	N/A	Flare Slope RT (%)	N/A
N/A	Flare Traversable LT?	N/A	N/A	Flare Traversable RT?	N/A
N/A	Landing Length (in)	N/A	N/A	DWS Provided?	N/A
N/A	Landing Width (in)	N/A	N/A	DWS Contrast?	N/A
N/A	Landing Slope (%)	N/A	N/A	DWS Length (in)	N/A
N/A	Landing X Slope (%)	N/A	N/A	DWS Full Width?	N/A
N/A	Landing Curb? (Y/N)	N/A	N/A	DWS Offset (in)	N/A
N/A	Shared Landing?	N/A			
N/A	Gutter Ponding?	N/A	N/A	Gutter Slope (%)	N/A
N/A	Gutter Lip Ht (in)	N/A	N/A	Gutter X Slope (%)	N/A
N/A	Painted X Walk1?	No	N/A	Painted X Walk2?	No
	X Walk 1 Direction	To S		X Walk 2 Direction	To E
N/A	X Walk 1 Width (in)	N/A	N/A	X Walk 2 Width (in)	N/A
	X Walk 1 Slope (%)	8.4		X Walk 2 Slope (%)	3.8
	X Walk 1 X Slope (%)	3.7		X Walk 2 X Slope (%)	6.9

N/A	Ramp inside XWalk1?	N/A	N/A	Ramp inside XWalk2?	N/A
	Road Slope (%)	2.1	N/A	Clear Space?	N/A
	Road X Slope (%)	8.4	N/A	Clear Space to XWalk (in)	N/A
N/A	Any Obstructions?	N/A	N/A	Storm Grate/Utility Hazard?	N/A
	Obstruction Type			Storm Grate/Utility Type	
		N/A			N/A
		Yes		Surface Condition? (G/P)	Good

Remove & Replace Curb Ramp With Two New Directional Ramps or Equivalent.

Total Cost: \$ 3200.00
