Access Compliance Report

Public Rights-of-Way

(Curb Ramps)

Intersection ID: 18787	Main Street: MONROE_RD	Cross Street: WOODBERRY_RD	Location: NE
ADA ID: 4742348D4A56	Ramp Type: PerpDiag	Initial Pass/Fail: Fail	Overall Compliance: No
		Severity Score: 13.75

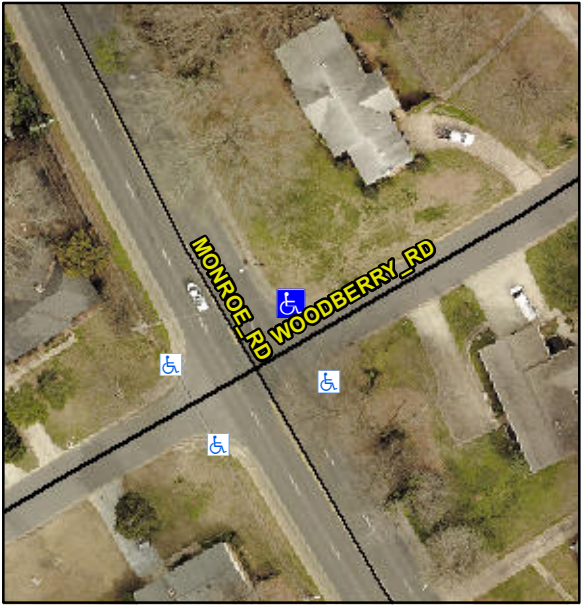
Possible Solutions:		Compliance	Description	Data
	Remove & Replace Curb Ramp With Two New Directional Ramps or Equivalent.		No	Ramp Length (in)	60.0
			Yes	Ramp Width (in)	48.0
			N/A	Flare Type LT	N/A
			N/A	Flare Slope LT (%)	N/A
			N/A	Flare Traversable LT?	N/A
			N/A	Landing Length (in)	N/A
			N/A	Landing Width (in)	N/A
			N/A	Landing Slope (%)	N/A
			N/A	Landing X Slope (%)	N/A
<p>Surveyor Notes:</p> <p>N/A</p> <p>PROW/ADA:</p> <p>Not Found, R304.2.2, R304.5.3</p>			N/A	Flare Type RT	N/A
			N/A	Flare Slope RT (%)	N/A
			N/A	Flare Traversable RT?	N/A
			N/A	DWS Provided?	N/A
			N/A	DWS Contrast?	N/A
			N/A	DWS Length (in)	N/A
			N/A	DWS Full Width?	N/A
			N/A	DWS Offset (in)	N/A
			N/A	Gutter Ponding?	N/A
			N/A	Gutter Lip Ht (in)	N/A
<p>Total Cost:</p> <p>\$ 3200.00</p>			No	Painted X Walk2?	No
			To W	X Walk 2 Direction	To S
