Access Compliance Report

Public Rights-of-Way

(Curb Ramps)

Intersection ID: 28438	Main Street: JESSICA_PL	Cross Street: PROSPERITY_VILLAGE_DR	Location: NW
ADA ID: 47E09F8B4D89	Ramp Type: Perp	Initial Pass/Fail: Fail	Overall Compliance: No
			Severity Score: 33.75

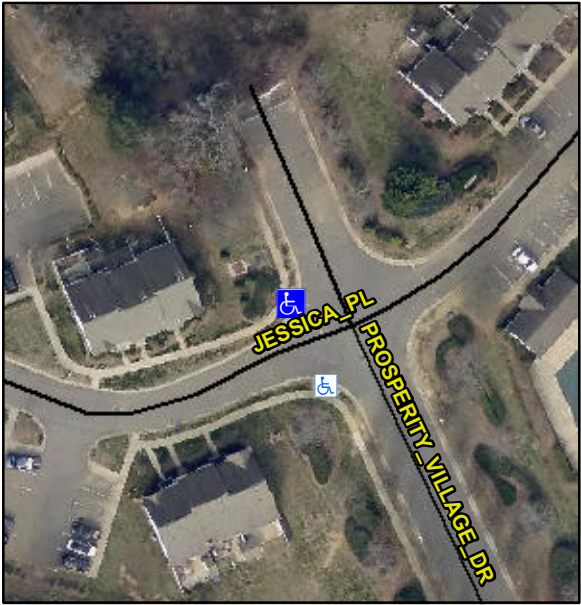
Possible Solutions:		Compliance	Description	Data
	Remove & Replace Entire Ramp.		N/A	Ramp Length (in)	50.0
			No	Ramp Width (in)	42.0
			N/A	Flare Type LT	N/A
			N/A	Flare Slope LT (%)	N/A
			N/A	Flare Traversable LT?	N/A
			N/A	Landing Length (in)	N/A
			N/A	Landing Width (in)	N/A
			N/A	Landing Slope (%)	N/A
			N/A	Landing X Slope (%)	N/A
			N/A	Landing Curb? (Y/N)	N/A
			N/A	Shared Landing?	N/A
			N/A	Gutter Ponding?	N/A
			N/A	Gutter Lip Ht (in)	N/A
			N/A	Painted X Walk1?	No
				X Walk 1 Direction	To S
			N/A	X Walk 1 Width (in)	N/A
				X Walk 1 Slope (%)	2.1
				X Walk 1 X Slope (%)	6.8
			N/A	Ramp inside XWalk1?	N/A
<p>Surveyor Notes:</p> <p>N/A</p> <p>PROW/ADA:</p> <p>R304.5.1, R304.2.2, R304.5.3</p>			N/A	Flare Type RT	N/A
			N/A	Flare Slope RT (%)	N/A
			N/A	Flare Traversable RT?	N/A
			N/A	DWS Provided?	N/A
			N/A	DWS Contrast?	N/A
