# Access Compliance Report

## Public Rights-of-Way

| Intersection ID: 5928 | Main Street: CRANDON_DR | Cross Street: PEACHTREE_RD | Location: NW |
| ADA ID: 48760D01204F | Ramp Type: Combination1 | Initial Pass/Fail: Fail | Overall Compliance: No |

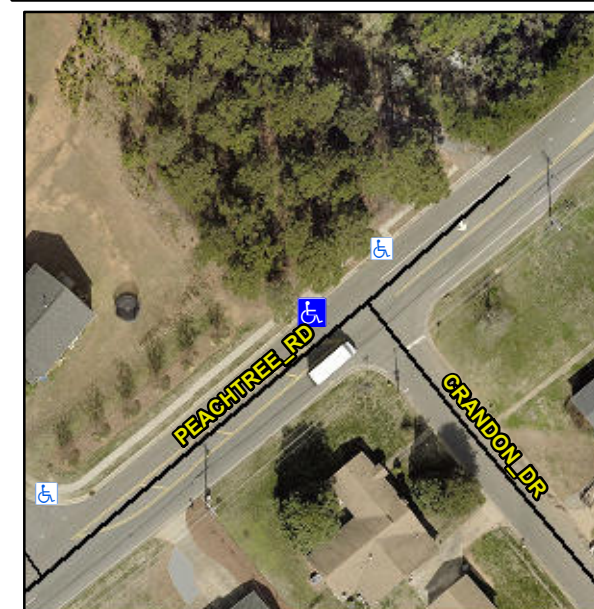
**LT RP < 5%**

**Not Found, R304.5.1, R304.5.3,  
R304.3.2**

**Remove & Replace Entire Ramp.  
Remove & Replace Sidewalk.**

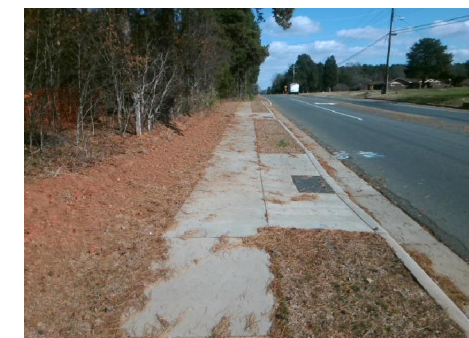
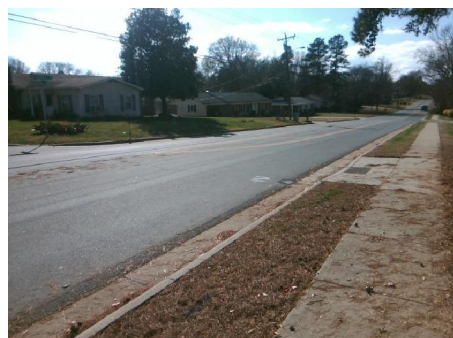
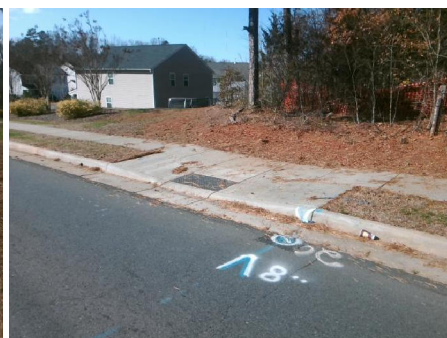
| Compliance | Description | Data | Compliance | Description | Data |
|---|---|---|---|---|---|
| No | Ramp Width LT (in) | 47.0 | No | Ramp Width RT (in) | 47.5 |
| Yes | Ramp Slope LT (%) | 1.6 | No | Ramp Slope RT (%) | 10.3 |
| No | Ramp XSlope LT (%) | 3.5 | No | Ramp XSlope RT (%) | 2.1 |
