Access Compliance Report

Public Rights-of-Way (Curb Ramps)

Intersection ID: 10608	Main Street: N_DAVIDSON_ST	Cross Street: JORDAN_PL	Location: SW
ADA ID: 48AAB93119A4	Ramp Type: Combination1	Initial Pass/Fail: Fail	Overall Compliance: No
		Severity Score: 8.75

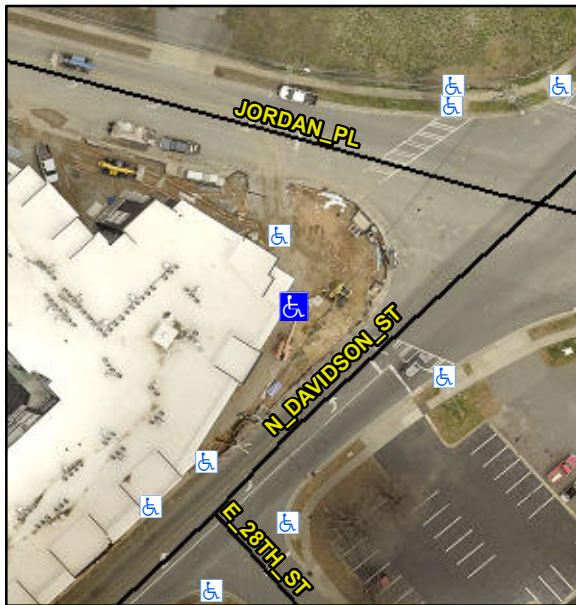
LT RP < 5%

Not Found, R304.5.1

Remove & Replace Entire Ramp.
