Access Compliance Report

Public Rights-of-Way

(Curb Ramps)

Intersection ID: 7027	Main Street: TALUS_TRACE_LN	Cross Street: BEGONIA_DR	Location:	S
ADA ID: 48CAD5B65179	Ramp Type: Perp	Initial Pass/Fail: Pass	Overall Compliance: No	Severity Score: 0

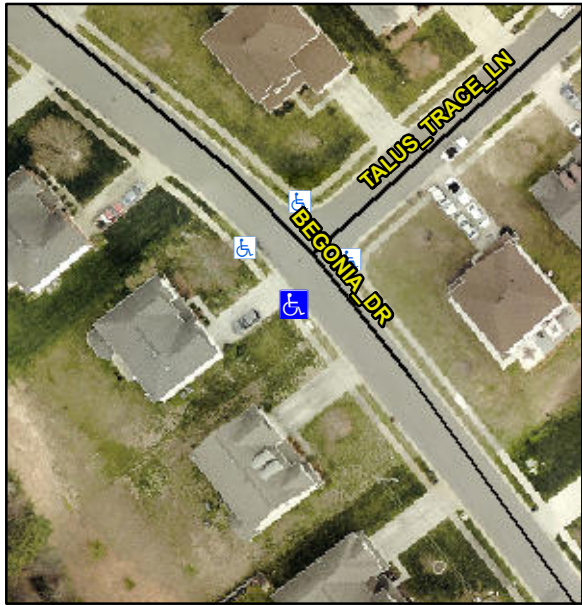
Possible Solutions:		Compliance	Description	Data	Compliance	Description	Data	
	Remove & Replace Entire Ramp.		N/A	Ramp Length (in)	46.5	Yes	Ramp Slope (%)	7.3	
	Remove & Replace Gutter.		Yes	Ramp Width (in)	50.5	Yes	Ramp XSlope (%)	1.6	
			N/A	Flare Type LT	Sloped	N/A	Flare Type RT	N/A	
			N/A	Flare Slope LT (%)	5.1	Yes	Flare Slope RT (%)	6.6	
			N/A	Flare Traversable LT?	No	N/A	Flare Traversable RT?	Yes	
			Yes	Landing Length (in)	48.0	Yes	DWS Provided?	Yes	
			Yes	Landing Width (in)	50.5	Yes	DWS Contrast?	Yes	
			Yes	Landing Slope (%)	1.6	Yes	DWS Length (in)	24.5	
			No	Landing X Slope (%)	2.1	Yes	DWS Full Width?	Yes	
Street 1 Name	Surveyor Notes:		N/A	Landing Curb? (Y/N)	No	Yes	DWS Offset (in)	0.8	
	PROW/ADA:			Shared Landing?	No				
	Not Found, R304.5.3		Yes	Gutter Ponding?	No	Yes	Gutter Slope (%)	1.5	
			Yes	Gutter Lip Ht (in)	0.0	No	Gutter X Slope (%)	2.2
