## **Access Compliance Report Public Rights-of-Way** (Curb Ramps)

Intersection ID: 45513 Main Street: FIRST BLOOM RD Cross Street: HEDGEROW PARK RD Location: ADA ID: 493BCAE8F56E Ramp Type: Perp Initial Pass/Fail: Fail **Overall Compliance: No** Severity Score: 13.75

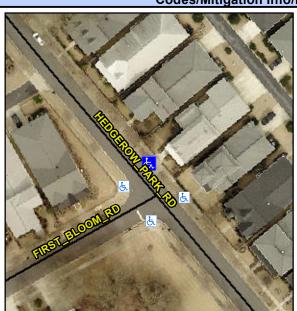
Field Measurements/Component Compliance					
Compliance Description		Data	Comp	liance Description	Data
N/A	Ramp Length (in)	71.0	No	Ramp Slope (%)	9.6
Yes	Ramp Width (in)	50.0	No	Ramp XSlope (%)	3.3
N/A	Flare Type LT	N/A	N/A	Flare Type RT	N/A
N/A	Flare Slope LT (%)	N/A	N/A	Flare Slope RT (%)	N/A
N/A	Flare Traversable LT?	N/A	N/A	Flare Traversable RT?	N/A
N/A	Landing Length (in)	N/A	N/A	DWS Provided?	N/A
N/A	Landing Width (in)	N/A	N/A	DWS Contrast?	N/A
N/A	Landing Slope (%)	N/A	N/A	DWS Length (in)	N/A
N/A	Landing X Slope (%)	N/A	N/A	DWS Full Width?	N/A
N/A	Landing Curb? (Y/N)	N/A	N/A	DWS Offset (in)	N/A
N/A	Shared Landing?	N/A			
N/A	Gutter Ponding?	N/A	N/A	Gutter Slope (%)	N/A
N/A	Gutter Lip Ht (in)	N/A	N/A	Gutter X Slope (%)	N/A
N/A	Painted X Walk1?	No	N/A	Painted X Walk2?	N/A
	X Walk 1 Direction	To SW		X Walk 2 Direction	N/A
N/A	X Walk 1 Width (in)	N/A	N/A	X Walk 2 Width (in)	N/A
	X Walk 1 Slope (%)	3.7		X Walk 2 Slope (%)	N/A

Possible Solutions: Remove & Replace Entire Ramp. Surveyor Notes: N/A PROW/ADA: Not Found, R304.2.2, R304.5.3
