# Access Compliance Report

## Public Rights-of-Way

### (Curb Ramps)

Intersection ID: 8606	Main Street: ISENHOUR_ST	Cross Street: JUSTICE_AV	Location: SW
ADA ID: 4962DAEAE303	Ramp Type: PerpDiag	Initial Pass/Fail: Fail	Overall Compliance: No
Severity Score: 46.25			
Codes/Mitigation Info/Possible Solution		Field Measurements/Component Compliance

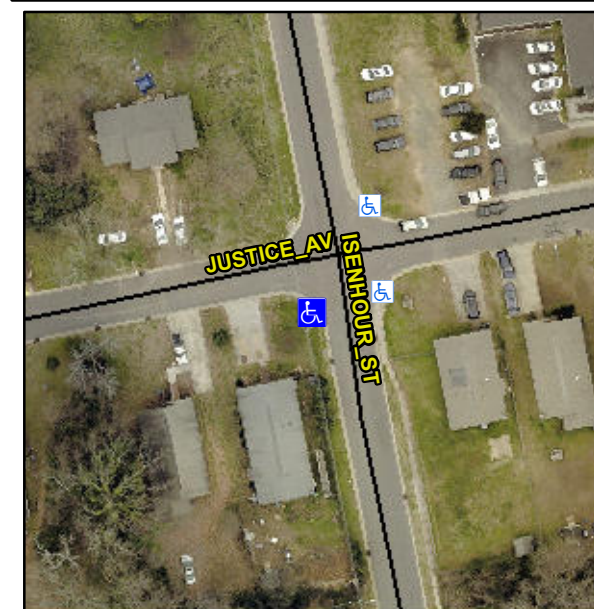
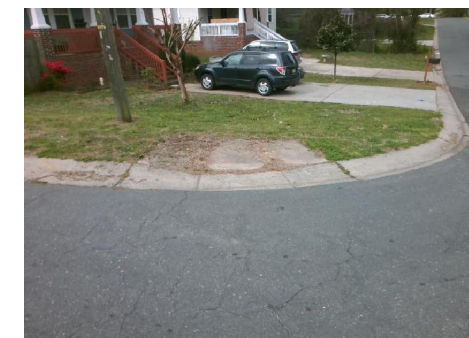
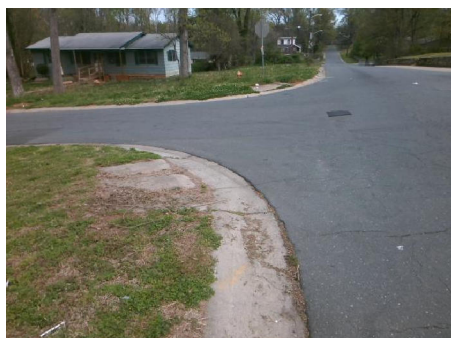
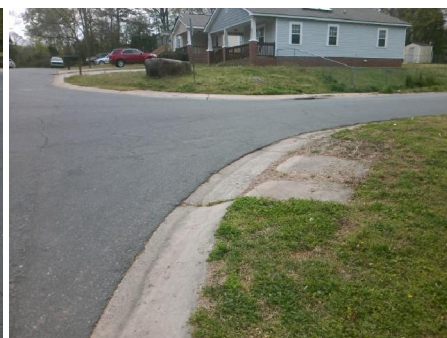
**Not Found, R304.5.1, R304.2.2, R304.5.3**

Compliance	Description	Data	Compliance	Description	Data
N/A	Ramp Length (in)	48.0	No	Ramp Slope (%)	8.7
No	Ramp Width (in)	36.0	No	Ramp XSlope (%)	10.1
N/A	Flare Type LT	N/A	N/A	Flare Type RT	N/A
N/A	Flare Slope LT (%)	N/A	N/A	Flare Slope RT (%)	N/A
N/A	Flare Traversable LT?	N/A	N/A	Flare Traversable RT?	N/A
N/A	Landing Length (in)	N/A	N/A	DWS Provided?	N/A
N/A	Landing Width (in)	N/A	N/A	DWS Contrast?	N/A
N/A	Landing Slope (%)	N/A	N/A	DWS Length (in)	N/A
N/A	Landing X Slope (%)	N/A	N/A	DWS Full Width?	N/A
N/A	Landing Curb? (Y/N)	N/A	N/A	DWS Offset (in)	N/A
N/A	Shared Landing?	N/A			
N/A	Gutter Ponding?	N/A	N/A	Gutter Slope (%)	N/A
N/A	Gutter Lip Ht (in)	N/A	N/A	Gutter X Slope (%)	N/A
N/A	Painted X Walk1?	No	N/A	Painted X Walk2?	No
	X Walk 1 Direction	To E		X Walk 2 Direction	To N
N/A	X Walk 1 Width (in)	N/A	N/A	X Walk 2 Width (in)	N/A
	X Walk 1 Slope (%)	6.0		X Walk 2 Slope (%)	4.5
	X Walk 1 X Slope (%)	5.6		X Walk 2 X Slope (%)	10.9

N/A	Ramp inside XWalk1?	N/A	N/A	Ramp inside XWalk2?	N/A
	Road Slope (%)	6.3	N/A	Clear Space?	N/A
	Road X Slope (%)	5.7	N/A	Clear Space to XWalk (in)	N/A
N/A	Any Obstructions?	N/A	N/A	Storm Grate/Utility Hazard?	N/A
	Obstruction Type			Storm Grate/Utility Type	
		N/A			N/A
		Yes		Surface Condition? (G/P)	Good

**Remove & Replace Curb Ramp With Two New Directional Ramps or Equivalent.**
