## **Access Compliance Report Public Rights-of-Way** (Curb Ramps)

Intersection ID: 8030 Main Street: RUTGERS\_AV Cross Street: W\_SUGAR\_CREEK\_RD Location: NW **Severity Score:** ADA ID: 496D6BF2AC6D Ramp Type: Para Initial Pass/Fail: Fail **Overall Compliance: No** 25

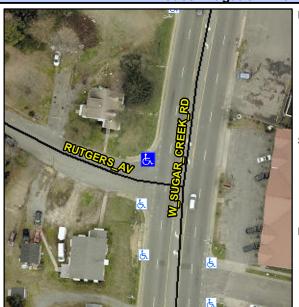
Field Measurements/Component Compliance									
Compl	iance Description	Data	Compl	iance Description	Data				
N/A	Ramp Length LT (in)	62.5	N/A	Ramp Length RT (in)	63.0				
Yes	Ramp Width LT (in)	50.0	Yes	Ramp Width RT (in)	50.0				
Yes	Ramp Slope LT (%)	0.3	No	Ramp Slope RT (%)	15.0				
Yes	Ramp XSlope LT (%)	1.3	Yes	<b>Yes</b> Ramp XSlope RT (%)					
N/A	Landing Length (in)	N/A	N/A	N/A DWS Provided?					
N/A	Landing Width (in)	N/A	N/A	DWS Contrast?	N/A				
N/A	Landing Slope (%)	N/A	N/A	DWS Length (in)	N/A				
N/A	Landing X Slope (%)	N/A	N/A	DWS Full Width?	N/A				
N/A	Landing Curb? (Y/N)	N/A	N/A	DWS Offset (in)	N/A				
N/A	Shared Landing?	N/A							
N/A	Gutter Ponding?	N/A	N/A	Gutter Slope (%)	N/A				
N/A	Gutter Lip Ht (in)	N/A	N/A	Gutter X Slope (%)	N/A				
N/A	Painted X Walk1?	No	N/A	Painted X Walk2?	N/A				
	X Walk 1 Direction	To S		X Walk 2 Direction	N/A				
N/A	X Walk 1 Width (in)	N/A	N/A	X Walk 2 Width (in)	N/A

X Walk 1 Slope (%)	0.0		X Walk 2 Slope (%)	N/A				
	X Walk 1 X Slope (%)	5.0		X Walk 2 X Slope (%)	N/A				
N/A	Ramp inside XWalk1?	N/A	N/A	Ramp inside XWalk2?	N/A				
	Road Slope (%)	N/A	N/A	Clear Space?	N/A				
	Road X Slope (%)	N/A	N/A	Clear Space to XWalk (in)	N/A				
N/A	Any Obstructions?	N/A	N/A	Storm Grate/Utility Hazard?	N/A				
	Obstruction Type			Storm Grate/Utility Type					
		N/A			N/A				
			Yes	Surface Condition? (G/P)	Good				
			N/A	Curb Slope (%)	28.8

Possible Solutions:	Cor
Remove & Replace Entire Ramp.	N/A
	Yes
	Yes
	Yes
	N/A
	N/A
Surveyor Notes:	N/A
LT RP < 5%	N/A
	N/A
	N/A
	N/A
PROW/ADA:	N/A
R304.3.2	N/A
	N/A
	N/A
