Access Compliance Report Public Rights-of-Way (Curb Ramps)

Intersection ID: 45829 Main Street: PATRICIA_ANN_LN Cross Street: CHRISTENBURY_HILLS_LN Location: SE

ADA ID: 498FA0A5D694 Ramp Type: Perp Initial Pass/Fail: Fail Overall Compliance: No Severity Score: 26.25

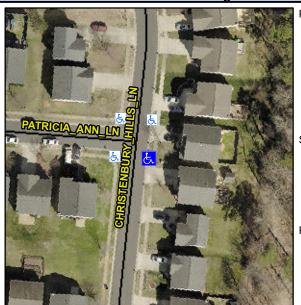
Field Measurements/Component Compliance								
Comp	liance Description	Data	Comp	liance Description	Data			
N/A	Ramp Length (in)	47.5	No	Ramp Slope (%)	16.5			
Yes	Ramp Width (in)	52.0	No	Ramp XSlope (%)	2.8			
N/A	Flare Type LT	N/A	N/A	Flare Type RT	N/A			
N/A	Flare Slope LT (%)	N/A	N/A	Flare Slope RT (%)	N/A			
N/A	Flare Traversable LT?	N/A	N/A	Flare Traversable RT?	N/A			
N/A	Landing Length (in)	N/A	N/A	DWS Provided?	N/A			
N/A	Landing Width (in)	N/A	N/A	DWS Contrast?	N/A			
N/A	Landing Slope (%)	N/A	N/A	DWS Length (in)	N/A			
N/A	Landing X Slope (%)	N/A	N/A	DWS Full Width?	N/A			
N/A	Landing Curb? (Y/N)	N/A	N/A	DWS Offset (in)	N/A			
N/A	Shared Landing?	N/A						
N/A	Gutter Ponding?	N/A	N/A	Gutter Slope (%)	N/A			
N/A	Gutter Lip Ht (in)	N/A	N/A	Gutter X Slope (%)	N/A			
N/A	Painted X Walk1?	No	N/A	Painted X Walk2?	N/A			
	X Walk 1 Direction	To W		X Walk 2 Direction	N/A			
N/A	X Walk 1 Width (in)	N/A	N/A	X Walk 2 Width (in)	N/A

X Walk 1 Slope (%)	2.7		X Walk 2 Slope (%)	N/A			
	X Walk 1 X Slope (%)	2.1		X Walk 2 X Slope (%)	N/A			
N/A	Ramp inside XWalk1?	N/A	N/A	Ramp inside XWalk2?	N/A			
	Road Slope (%)	N/A	N/A	Clear Space?	N/A			
	Road X Slope (%)	N/A	N/A	Clear Space to XWalk (in)	N/A			
N/A	Any Obstructions?	N/A	N/A	Storm Grate/Utility Hazard?	N/A			
	Obstruction Type			Storm Grate/Utility Type				
		N/A			N/A			
			Yes	Surface Condition? (G/P)	Good

Possible Solution	
Possible Solutions:	Cor
Remove & Replace Entire Ramp.	N/A
·	Yes
	N/A
	N/A
	N/A
	N/A
Surveyor Notes:	N/A
N/A	N/A
	N/A
	N/A
	N/A
PROW/ADA:	N/A
R304.2.2, R304.5.3	N/A
,	N/A
	N/A
	NI/A
