Access Compliance Report Public Rights-of-Way (Curb Ramps)

Cross Street: ROSE_CREEK_CT Intersection ID: 46811 Main Street: ARBOR_VISTA_DR Location: S **Overall Compliance: No Severity Score:** 12.5 ADA ID: 4A18B4C96095 Ramp Type: Perp Initial Pass/Fail: Fail

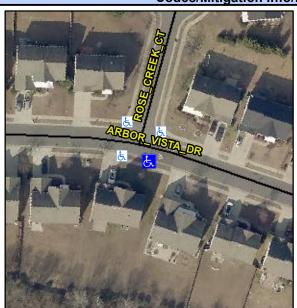
Field Measurements/Component Compliance							
Comp	liance Description	Data	Comp	liance Description	Data		
N/A	Ramp Length (in)	47.0	No	Ramp Slope (%)	9.5		
Yes	Ramp Width (in)	58.0	Yes	Ramp XSlope (%)	0.9		
N/A	Flare Type LT	N/A	N/A	Flare Type RT	N/A		
N/A	Flare Slope LT (%)	N/A	N/A	Flare Slope RT (%)	N/A		
N/A	Flare Traversable LT?	N/A	N/A	Flare Traversable RT?	N/A		
N/A	Landing Length (in)	N/A	N/A	DWS Provided?	N/A		
N/A	Landing Width (in)	N/A	N/A	DWS Contrast?	N/A		
N/A	Landing Slope (%)	N/A	N/A	DWS Length (in)	N/A		
N/A	Landing X Slope (%)	N/A	N/A	DWS Full Width?	N/A		
N/A	Landing Curb? (Y/N)	N/A	N/A	DWS Offset (in)	N/A		
N/A	Shared Landing?	N/A					
N/A	Gutter Ponding?	N/A	N/A	Gutter Slope (%)	N/A		
N/A	Gutter Lip Ht (in)	N/A	N/A	Gutter X Slope (%)	N/A		
N/A	Painted X Walk1?	No	N/A	Painted X Walk2?	N/A		
	X Walk 1 Direction	To NE		X Walk 2 Direction	N/A		
N/A	X Walk 1 Width (in)	N/A	N/A	X Walk 2 Width (in)	N/A

Possible Solutions:	Con
Remove & Replace Entire Ramp.	N/A
	Yes
	N/A
	N/A
	N/A
	N/A
Surveyor Notes:	N/A
N/A	N/A
	N/A
	N/A
	N/A
PROW/ADA:	N/A
Not Found, R304.2.2	N/A
	N/A
	N/A
	N/A
