## Access Compliance Report Public Rights-of-Way (Curb Ramps)

Intersection ID: N/A Main Street: PROVIDENCE\_PROMINADE\_DRCross Street: HENRY\_QUINCY\_WY Location: SW

ADA ID: 4A6CD955C14D Ramp Type: PerpDiag Initial Pass/Fail: Fail Overall Compliance: No Severity Score: 33.75

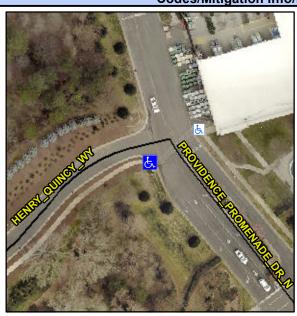
Not Found, R304.5.1, R304.2.2, R304.5.3

Remove & Replace Curb Ramp With Two New Directional Ramps or Equivalent.
