Access Compliance Report Public Rights-of-Way (Curb Ramps)

Intersection ID: 4823 Main Street: BEN_CRAIG_DR Cross Street: J_N_PEASE_PL Location: SW **Overall Compliance: No** ADA ID: 4ABFB3003C58 Ramp Type: PerpDiag Initial Pass/Fail: Fail **Severity Score:** 25

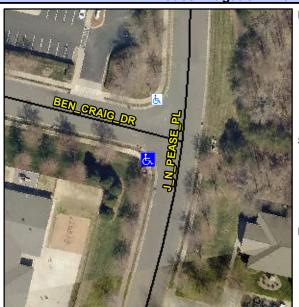
Field Measurements/Component Compliance								
	Compliance Description		Data	Comp	liance Description	Data			
	N/A	Ramp Length (in)	36.0	No	Ramp Slope (%)	9.6			
	Yes	Ramp Width (in)	48.0	No	Ramp XSlope (%)	6.7			
	N/A	Flare Type LT	N/A	N/A	Flare Type RT	N/A			
	N/A	Flare Slope LT (%)	N/A	N/A	Flare Slope RT (%)	N/A			
	N/A	Flare Traversable LT?	N/A	N/A	Flare Traversable RT?	N/A			
	N/A	Landing Length (in)	N/A	N/A	DWS Provided?	N/A			
	N/A	Landing Width (in)	N/A	N/A	DWS Contrast?	N/A			
	N/A	Landing Slope (%)	N/A	N/A	DWS Length (in)	N/A			
	N/A	Landing X Slope (%)	N/A	N/A	DWS Full Width?	N/A			
	N/A	Landing Curb? (Y/N)	N/A	N/A	DWS Offset (in)	N/A			
	N/A	Shared Landing?	N/A						
	N/A	Gutter Ponding?	N/A	N/A	Gutter Slope (%)	N/A			
	N/A	Gutter Lip Ht (in)	N/A	N/A	Gutter X Slope (%)	N/A			
	N/A	Painted X Walk1?	No	N/A	Painted X Walk2?	No			
		X Walk 1 Direction	To E		X Walk 2 Direction	To N			
	N/A	X Walk 1 Width (in)	N/A	N/A	X Walk 2 Width (in)	N/A

X Walk 1 Slope (%)	4.3		X Walk 2 Slope (%)	3.3			
		X Walk 1 X Slope (%)	5.2		X Walk 2 X Slope (%)	3.0			
	N/A	Ramp inside XWalk1?	N/A	N/A	Ramp inside XWalk2?	N/A			
		Road Slope (%)	5.6	N/A	Clear Space?	N/A			
		Road X Slope (%)	0.2	N/A	Clear Space to XWalk (in)	N/A			
	N/A	Any Obstructions?	N/A	N/A	Storm Grate/Utility Hazard?	N/A			
		Obstruction Type			Storm Grate/Utility Type				
			N/A			N/A			
				Yes	Surface Condition? (G/P)	Good

Possible Solution	
Possible Solutions:	9
Remove & Replace Curb Ramp With	N
Two New Directional Ramps or	Y
Equivalent.	N
	1
	1
	1
Surveyor Notes:	1
N/A	1
	1
	1
	1
PROW/ADA:	1
Not Found, R304.2.2, R304.5.3	N
	1
	N
