# Access Compliance Report

## Public Rights-of-Way

### (Curb Ramps)

| Intersection ID: 30433 | Main Street: CEDAR_ROCK_DR | Cross Street: NANNYBERRY_LN | Location: SW |

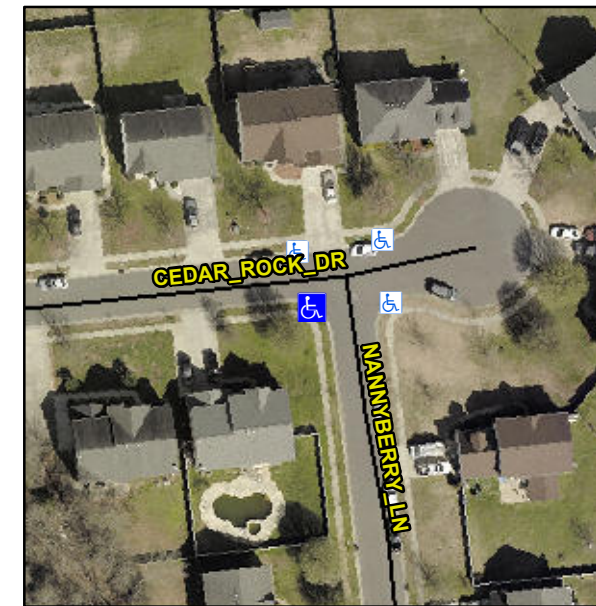
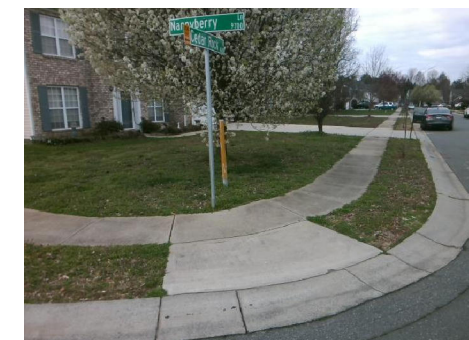
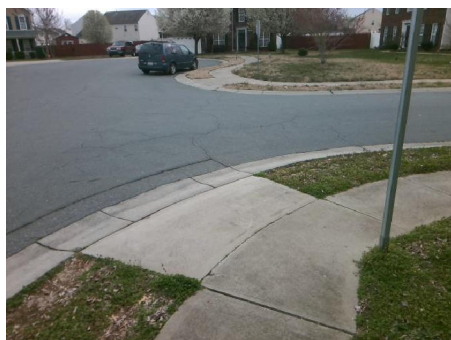
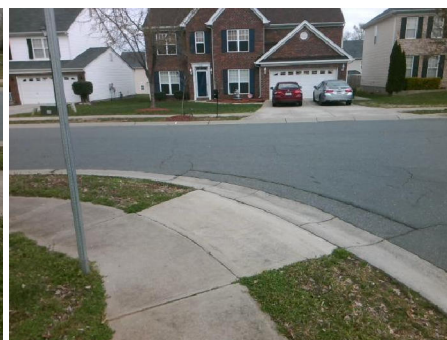
| ADA ID: 4B1EC22D55B8 | Ramp Type: PerpDiag | Initial Pass/Fail: Pass | Overall Compliance: No |
| | | | Severity Score: 25 |

**Not Found, R304.2.1, R304.2.2-Perp, R304.3.2-Para, R304.5.3, R305, R304.5.4**

| Compliance | Description | Data | Compliance | Description | Data |
|---|---|---|---|---|---|
| No | Landing Length (in) | N/A | No | DWS Provided? | No |
| No | Landing Width (in) | N/A | N/A | DWS Contrast? | No |
| No | Landing Slope (%) | N/A | N/A | DWS Length (in) | N/A |
| No | Landing X Slope (%) | N/A | N/A | DWS Full Width? | No |
| Yes | Gutter Ponding? | No | No | Gutter Slope (%) | 5.2 |
| Yes | Gutter Lip Ht (in) | 0.0 | No | Gutter X Slope (%) | 2.3 |

**Remove & Replace Curb Ramp With Two New Directional Ramps or Equivalent. Remove & Replace Gutter.**
