# Access Compliance Report

## Public Rights-of-Way

### (Curb Ramps)

Intersection ID: 2898	Main Street: MISTY_ARBOR_WY	Cross Street: WINTER_PINE_LN	Location: E
ADA ID: 4C5CC9808C20	Ramp Type: Perp	Initial Pass/Fail: Fail	Overall Compliance: No
Severity Score: 12.5			
Codes/Mitigation Info/Possible Solution		Field Measurements/Component Compliance

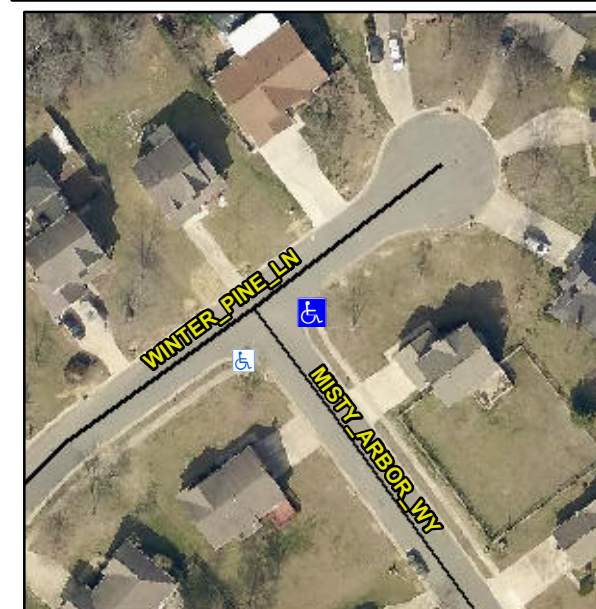
**Not Found, R304.2.2**

Compliance	Description	Data	Compliance	Description	Data
N/A	Ramp Length (in)	72.0	No	Ramp Slope (%)	8.5
Yes	Ramp Width (in)	120.0	Yes	Ramp XSlope (%)	1.4
N/A	Flare Type LT	N/A	N/A	Flare Type RT	N/A
N/A	Flare Slope LT (%)	N/A	N/A	Flare Slope RT (%)	N/A
N/A	Flare Traversable LT?	N/A	N/A	Flare Traversable RT?	N/A
N/A	Landing Length (in)	N/A	N/A	DWS Provided?	N/A
N/A	Landing Width (in)	N/A	N/A	DWS Contrast?	N/A
N/A	Landing Slope (%)	N/A	N/A	DWS Length (in)	N/A
N/A	Landing X Slope (%)	N/A	N/A	DWS Full Width?	N/A
N/A	Landing Curb? (Y/N)	N/A	N/A	DWS Offset (in)	N/A
N/A	Shared Landing?	N/A			
N/A	Gutter Ponding?	N/A	N/A	Gutter Slope (%)	N/A
N/A	Gutter Lip Ht (in)	N/A	N/A	Gutter X Slope (%)	N/A
N/A	Painted X Walk1?	No	N/A	Painted X Walk2?	N/A
	X Walk 1 Direction	To SW		X Walk 2 Direction	N/A
N/A	X Walk 1 Width (in)	N/A	N/A	X Walk 2 Width (in)	N/A
	X Walk 1 Slope (%)	2.2		X Walk 2 Slope (%)	N/A
	X Walk 1 X Slope (%)	4.8		X Walk 2 X Slope (%)	N/A

**Remove & Replace Entire Ramp.**
