Access Compliance Report

Public Rights-of-Way

(Curb Ramps)

Intersection ID: 13865	Main Street: CENTRAL_AV	Cross Street: TIMBER_HOLLOW_DR	Location: NW
ADA ID: 4CA8BBC485A8	Ramp Type: Combination1	Initial Pass/Fail: Fail	Overall Compliance: No
		Severity Score: 22.5

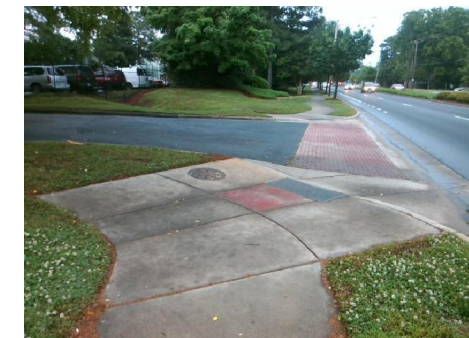
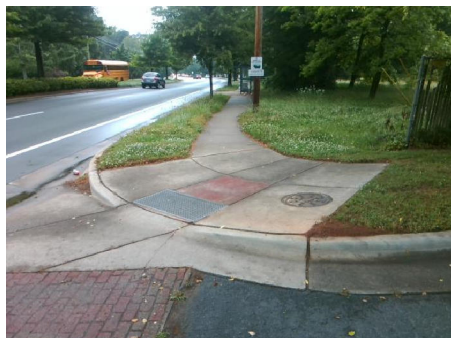
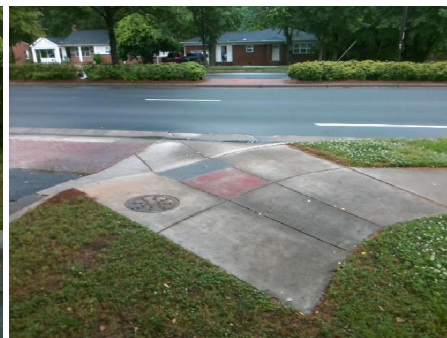
LT RP < 5%

Not Found, R304.5.1, R304.5.3, R304.3.2

Compliance	Description	Data	Compliance	Description	Data
N/A	Ramp Length LT (in)	43.0	N/A	Ramp Length RT (in)	45.0
Yes	Ramp Width LT (in)	72.0	Yes	Ramp Width RT (in)	71.0
Yes	Ramp Slope LT (%)	0.5	No	Ramp Slope RT (%)	10.7
Yes	Ramp XSlope LT (%)	1.1	Yes	Ramp XSlope RT (%)	0.4
N/A	Ramp Length (in)	72.0	Yes	Ramp Slope (%)	4.2
No	Ramp Width (in)	38.0	No	Ramp XSlope (%)	3.2
N/A	Flare Type LT	N/A	N/A	Flare Type RT	N/A
N/A	Flare Slope LT (%)	N/A	N/A	Flare Slope RT (%)	N/A
N/A	Flare Traversable LT?	N/A	N/A	Flare Traversable RT?	N/A
N/A	Landing Length (in)	N/A	N/A	DWS Provided?	N/A
N/A	Landing Width (in)	N/A	N/A	DWS Contrast?	N/A
N/A	Landing Slope (%)	N/A	N/A	DWS Length (in)	N/A
N/A	Landing X Slope (%)	N/A	N/A	DWS Full Width?	N/A
N/A	Landing Curb? (Y/N)	N/A	N/A	DWS Offset (in)	N/A
N/A	Shared Landing?	N/A			
N/A	Gutter Ponding?	N/A	N/A	Gutter Slope (%)	N/A
N/A	Gutter Lip Ht (in)	N/A	N/A	Gutter X Slope (%)	N/A
N/A	Painted X Walk1?	Yes	N/A	Painted X Walk2?	N/A

X Walk 1 Direction	To SE		X Walk 2 Direction	N/A
	X Walk 1 Width (in)	93.0		X Walk 2 Width (in)	N/A
	X Walk 1 Slope (%)	0.9		X Walk 2 Slope (%)	N/A
	X Walk 1 X Slope (%)	5.8		X Walk 2 X Slope (%)	N/A
N/A	Ramp inside XWalk1?	Yes	N/A	Ramp inside XWalk2?	N/A
	Road Slope (%)	N/A		Clear Space?	N/A
	Road X Slope (%)	N/A	N/A	Clear Space to XWalk (in)	N/A
			N/A	Any Obstruction?	N/A
				Obstruction Type	N/A
			N/A	Storm Grate/Utility Hazard?	N/A
				Storm Grate/Utility Type	N/A
			Yes	Surface Condition? (G/P)	Good
				Curb Slope (%)	20.3

Remove & Replace Entire Ramp.
