Access Compliance Report

Public Rights-of-Way

(Curb Ramps)

| Intersection ID: 50598 | Main Street: BENDING_BRANCH_RD | Cross Street: BEAR_GRASS_LN | Location: NE |

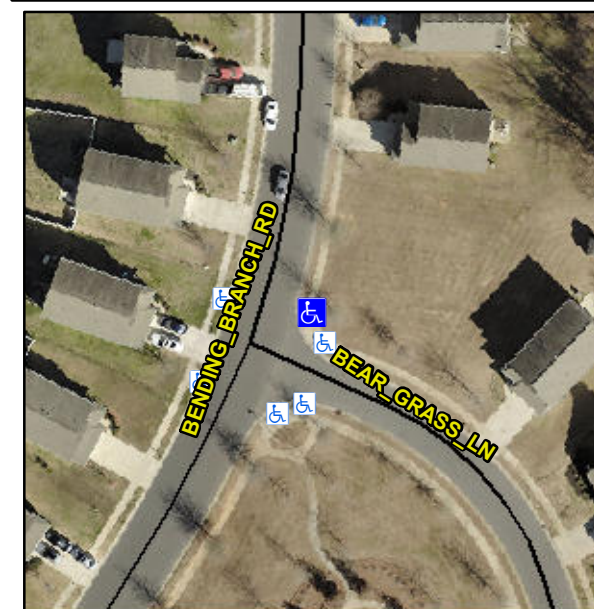
Not Found, R304.5.1, R304.2.2

| Compliance | Description | Data | Compliance | Description | Data |
|---|---|---|---|---|---|
| N/A | Ramp Length (in) | 48.0 | No | Ramp Slope (%) | 12.5 |
| No | Ramp Width (in) | 47.0 | Yes | Ramp XSlope (%) | 1.9 |

Remove & Replace Entire Ramp.
