# Access Compliance Report

## Public Rights-of-Way

### (Curb Ramps)

| Intersection ID: 29330 | Main Street: IRWIN_WOOD_LN | Cross Street: NEVIN_BROOK_RD | Location: NW |

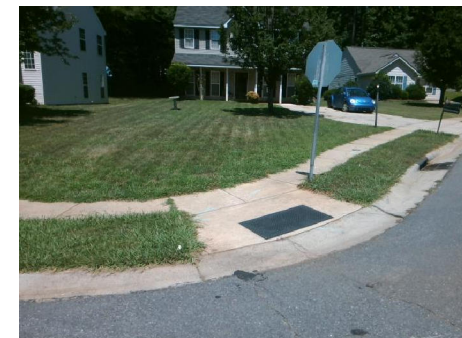
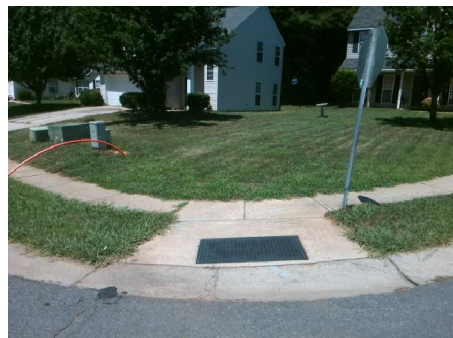
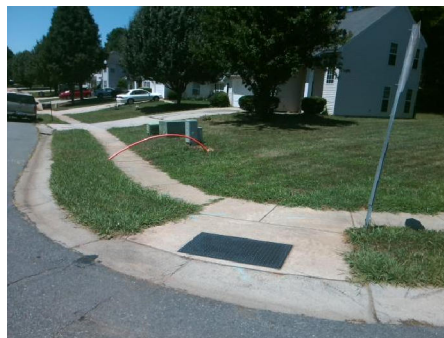
| ADA ID: 4D71BFD0CC8C | Ramp Type: BlendTrans1 | Initial Pass/Fail: Fail | Overall Compliance: No |

**Not Found, R304.5.3**

| Compliance | Description | Data | Compliance | Description | Data |
|---|---|---|---|---|---|
| Yes | Ramp Width (in) | 48.0 | No | BlendTrans XSlope (%) | 7.5 |
| | | | No | Curb Slope (%) | 7.0 |

**Remove & Replace Curb Ramp With Two New Directional Ramps or Equivalent.**
