Access Compliance Report

Public Rights-of-Way

| Intersection ID: 12473 | Main Street: S_CLARKSON_ST | Cross Street: W_PALMER_ST | Location: W |
| ADA ID: 4D897DB7D48B | Ramp Type: PerpDiag | Initial Pass/Fail: Fail | Overall Compliance: No |

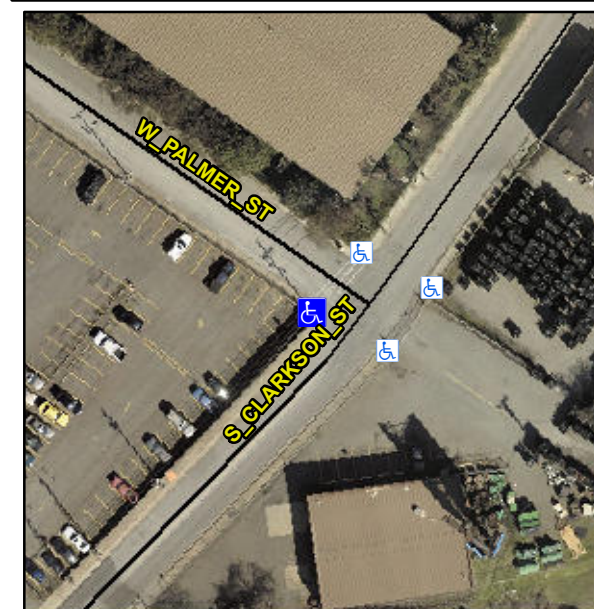
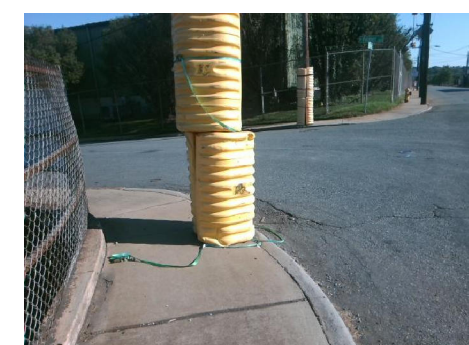
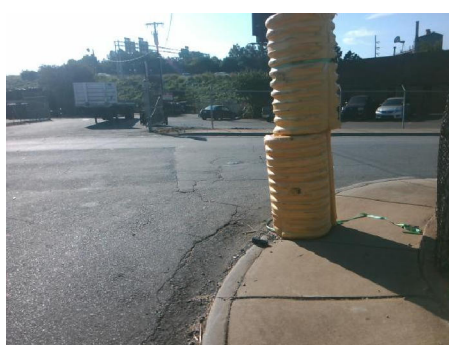
Not Found, R304.2.2, R304.5.3

| Compliance | Description | Data | Compliance | Description | Data |
|---|---|---|---|---|---|
| N/A | Ramp Length (in) | 53.0 | No | Ramp Slope (%) | 8.6 |
| Yes | Ramp Width (in) | 72.0 | No | Ramp XSlope (%) | 2.1 |

Remove & Replace Curb Ramp With Two New Directional Ramps or Equivalent.
