# Access Compliance Report

## Public Rights-of-Way

| Intersection ID: 3221 | Main Street: FAIRBOURNE_CT | Cross Street: HIGHCROFT_LN | Location: NW |
| ADA ID: 4D8F46549BF3 | Ramp Type: Perp | Initial Pass/Fail: Fail | Overall Compliance: No |

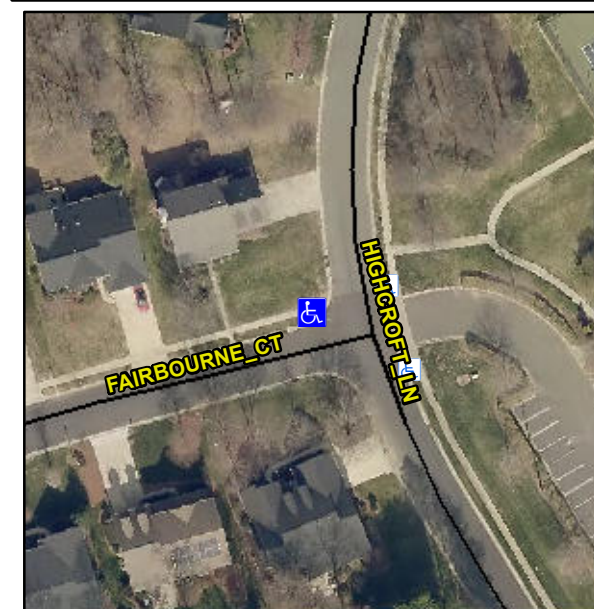
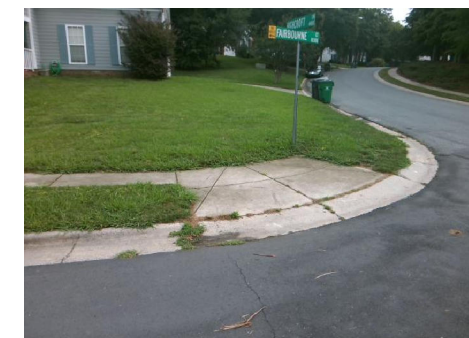
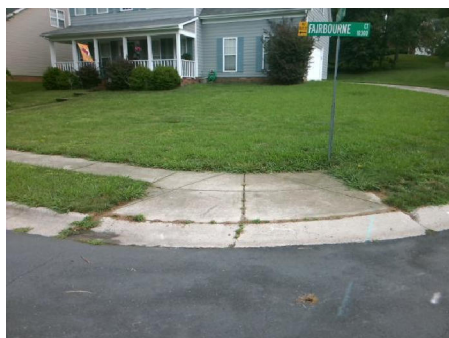
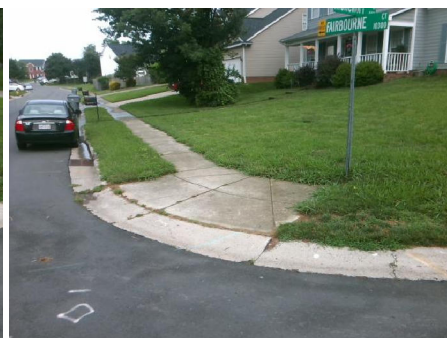
| Severity Score: 13.75 | | | |

**Not Found, R304.2.2, R304.5.3**

| Compliance | Description | Data | Compliance | Description | Data |
|---|---|---|---|---|---|
| N/A | Ramp Length (in) | 45.0 | No | Ramp Slope (%) | 8.6 |
| Yes | Ramp Width (in) | 90.0 | No | Ramp XSlope (%) | 3.7 |

**Remove & Replace Entire Ramp.**

Total Cost: \$ 1850.00
