Access Compliance Report

Public Rights-of-Way

(Curb Ramps)

Intersection ID: 15675	Main Street: EAST_BV	Cross Street: LOMBARDY_CR	Location: W
ADA ID: 4E09500C8055	Ramp Type: PerpDiag	Initial Pass/Fail: Fail	Overall Compliance: No
Severity Score: 13.75			
Codes/Mitigation Info/Possible Solution		Field Measurements/Component Compliance

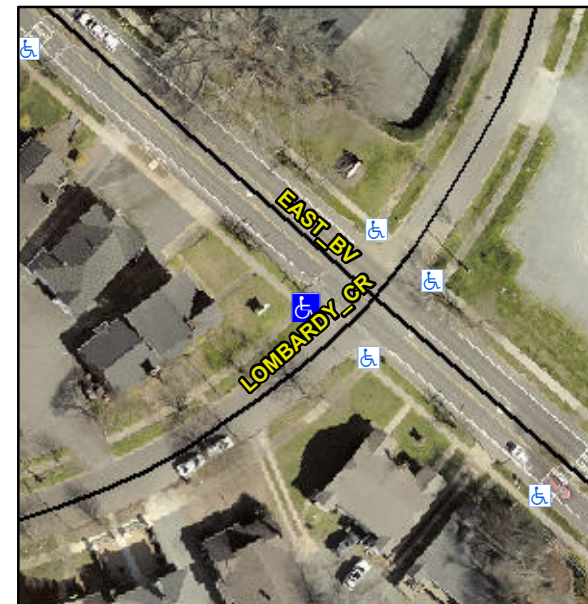
Not Found, R304.2.2, R304.5.3

Compliance	Description	Data	Compliance	Description	Data
N/A	Ramp Length (in)	115.0	No	Ramp Slope (%)	10.0
Yes	Ramp Width (in)	48.0	No	Ramp XSlope (%)	2.9
N/A	Flare Type LT	N/A	N/A	Flare Type RT	N/A
N/A	Flare Slope LT (%)	N/A	N/A	Flare Slope RT (%)	N/A
N/A	Flare Traversable LT?	N/A	N/A	Flare Traversable RT?	N/A
N/A	Landing Length (in)	N/A	N/A	DWS Provided?	N/A
N/A	Landing Width (in)	N/A	N/A	DWS Contrast?	N/A
N/A	Landing Slope (%)	N/A	N/A	DWS Length (in)	N/A
N/A	Landing X Slope (%)	N/A	N/A	DWS Full Width?	N/A
N/A	Landing Curb? (Y/N)	N/A	N/A	DWS Offset (in)	N/A
N/A	Shared Landing?	N/A			
N/A	Gutter Ponding?	N/A	N/A	Gutter Slope (%)	N/A
N/A	Gutter Lip Ht (in)	N/A	N/A	Gutter X Slope (%)	N/A
N/A	Painted X Walk1?	No	N/A	Painted X Walk2?	No
	X Walk 1 Direction	To SE		X Walk 2 Direction	To NE
N/A	X Walk 1 Width (in)	N/A	N/A	X Walk 2 Width (in)	N/A
	X Walk 1 Slope (%)	1.7		X Walk 2 Slope (%)	3.8
	X Walk 1 X Slope (%)	0.2		X Walk 2 X Slope (%)	0.2

Remove & Replace Curb Ramp With Two New Directional Ramps or Equivalent.

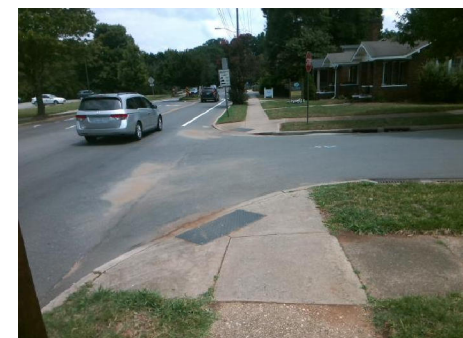
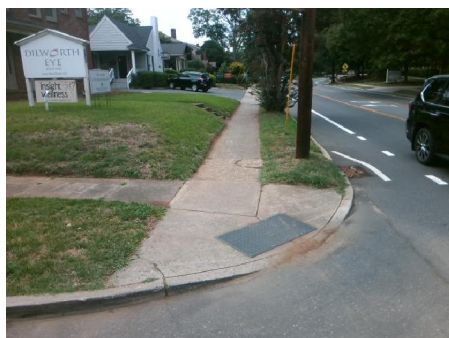
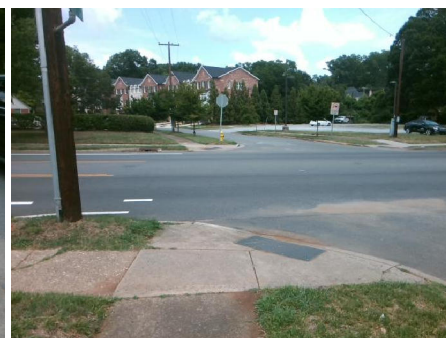
N/A	Ramp inside XWalk1?	N/A	N/A	Ramp inside XWalk2?	N/A
	Road Slope (%)	0.2	N/A	Clear Space?	N/A
	Road X Slope (%)	0.2	N/A	Clear Space to XWalk (in)	N/A
N/A	Any Obstructions?	N/A	N/A	Storm Grate/Utility Hazard?	N/A
	Obstruction Type			Storm Grate/Utility Type	
		N/A			N/A
			Yes	Surface Condition? (G/P)	Good
