Access Compliance Report

Public Rights-of-Way

(Curb Ramps)

Intersection ID: 11262	Main Street: EASTWAY_DR	Cross Street: FRONTENAC_AV	Location: NW
ADA ID: 4EA38F90A579	Ramp Type: Combination1	Initial Pass/Fail: Fail	Overall Compliance: No
		Severity Score: 10

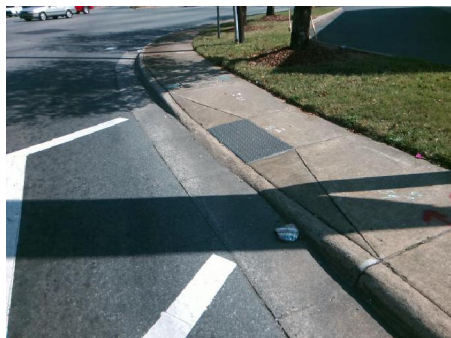
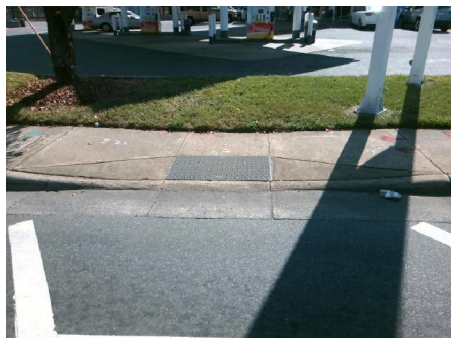
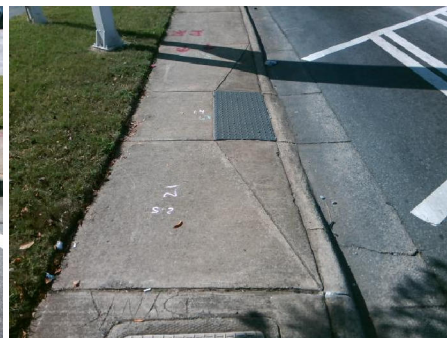
LT RP < 5%

Not Found, R304.5.1, R304.5.3

**Remove & Replace Entire Ramp.
Remove & Replace Sidewalk.**
