# Access Compliance Report

## Public Rights-of-Way

| Intersection ID: 23352 | Main Street: LANCER_DR | Cross Street: LONDONTOWNE_DR | Location: NE |
| ADA ID: 4F28A1670DD1 | Ramp Type: PerpDiag | Initial Pass/Fail: Fail | Overall Compliance: No |

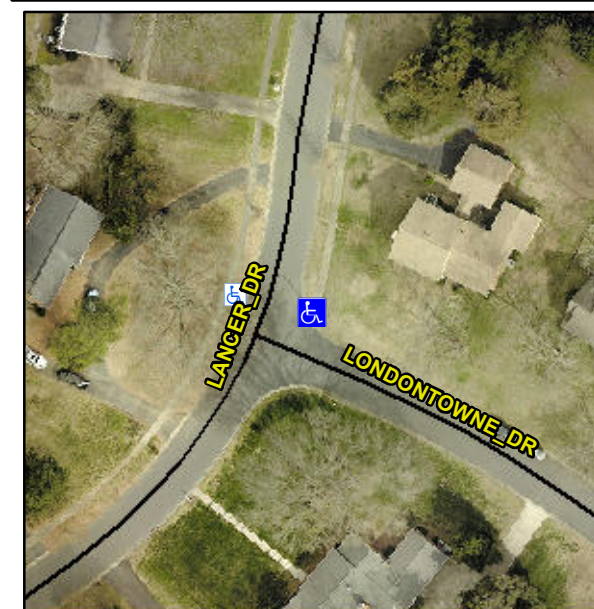
**Not Found, R304.5.1**

| Compliance | Description | Data | Compliance | Description | Data |
|---|---|---|---|---|---|
| N/A | Ramp Length (in) | 80.0 | Yes | Ramp Slope (%) | 6.7 |
| No | Ramp Width (in) | 40.5 | Yes | Ramp XSlope (%) | 0.4 |

**Remove & Replace Curb Ramp With Two New Directional Ramps or Equivalent.**
