## Access Compliance Report Public Rights-of-Way (Curb Ramps)

Intersection ID: 2896Main Street:ALLNESS\_GLEN\_LNCross Street:HARBURN\_FOREST\_DRLocation:SEADA ID: 4F28C2D5221ARamp Type:PerpDiagInitial Pass/Fail:FailOverall Compliance:NoSeverity Score:25

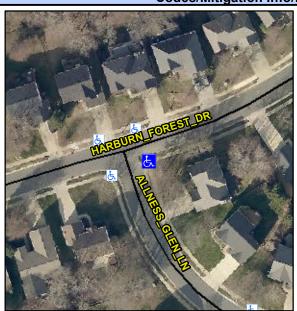
PROW/ADA:
Not Found, R304.2.2

ricia measarements/osmponent osmphanee					
Compliance Description		Data	Compliance Description		Data
N/A	Ramp Length (in)	48.0	No	Ramp Slope (%)	14.6
Yes	Ramp Width (in)	49.5	Yes	Ramp XSlope (%)	1.1
N/A	Flare Type LT	N/A	N/A	Flare Type RT	N/A
N/A	Flare Slope LT (%)	N/A	N/A	Flare Slope RT (%)	N/A
N/A	Flare Traversable LT?	N/A	N/A	Flare Traversable RT?	N/A
N/A	Landing Length (in)	N/A	N/A	DWS Provided?	N/A
N/A	Landing Width (in)	N/A	N/A	DWS Contrast?	N/A
N/A	Landing Slope (%)	N/A	N/A	DWS Length (in)	N/A
N/A	Landing X Slope (%)	N/A	N/A	DWS Full Width?	N/A
N/A	Landing Curb? (Y/N)	N/A	N/A	DWS Offset (in)	N/A
N/A	Shared Landing?	N/A			
N/A	Gutter Ponding?	Yes	N/A	Gutter Slope (%)	N/A
N/A	Gutter Lip Ht (in)	N/A	N/A	Gutter X Slope (%)	N/A
N/A	Painted X Walk1?	No	N/A	Painted X Walk2?	No
	X Walk 1 Direction	To N		X Walk 2 Direction	To W
N/A	X Walk 1 Width (in)	N/A	N/A	X Walk 2 Width (in)	N/A
	X Walk 1 Slope (%)	3.6		X Walk 2 Slope (%)	1.7

Remove & Replace Curb Ramp With
Two New Directional Ramps or
Equivalent.
