# Access Compliance Report

## Public Rights-of-Way

### (Curb Ramps)

| Intersection ID: 48948 | Main Street: BIRCHLEY_CR | Cross Street: DAVID_JENNINGS_AV | Location: W |

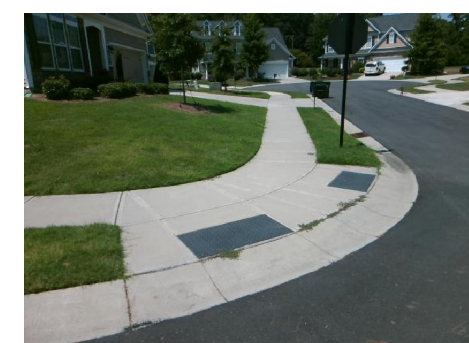
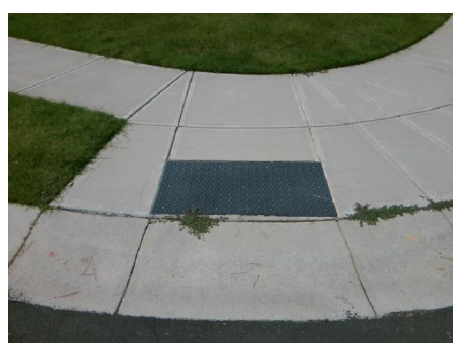
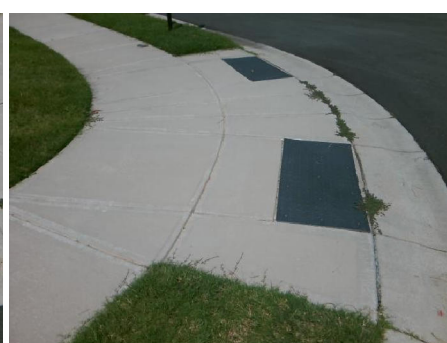
| ADA ID: 4F632B588534 | Ramp Type: Perp | Initial Pass/Fail: Fail | Overall Compliance: No |
| Severity Score: 8.75 | | | |

**Not Found, R304.5.1**

| Compliance | Description | Data | Compliance | Description | Data |
|---|---|---|---|---|---|
| No | Ramp Width (in) | 47.0 | Yes | Ramp XSlope (%) | 1.8 |

**Remove & Replace Entire Ramp.**

Total Cost: \$ 1850.00
