Access Compliance Report Public Rights-of-Way (Curb Ramps)

Intersection ID: 14373Main Street: EAST_BVCross Street: LYNDHURST_AVLocation:NEADA ID: 4FB6C423A73CRamp Type: Directional1Initial Pass/Fail: PassOverall Compliance: NoSeverity Score: 0.25

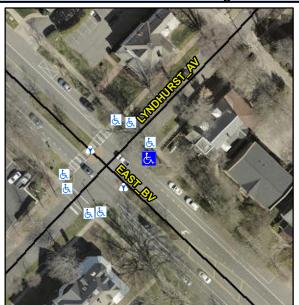
| Compliance Description Data | | | Compliance Description Data | | |
|---|---|---|---|---|---|
| Yes | Ramp Width (in) | 72.0 | No | Grade Break Slope (%) | 8.3 |
| No | Ramp XSlope (%) | 2.5 | | | |

Remove & Replace Entire Ramp.

R304.5.3
