# Access Compliance Report

## Public Rights-of-Way

### (Curb Ramps)

| Intersection ID: 45505 | Main Street: GINHOUSE_LN | Cross Street: MEADOW_BOTTOM_RD | Location: NW |

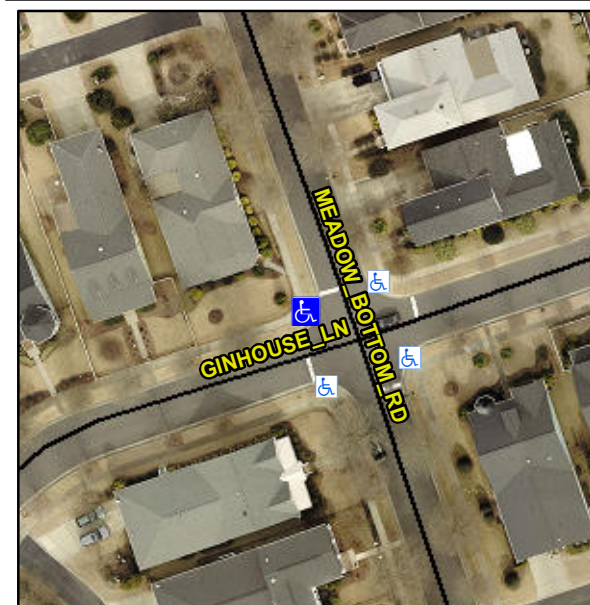
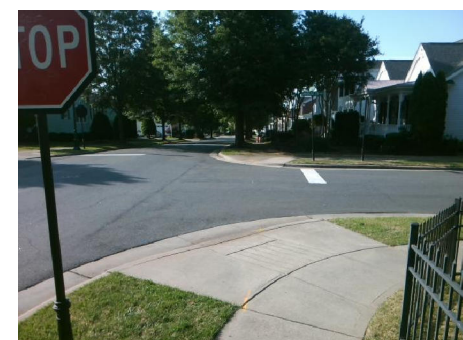
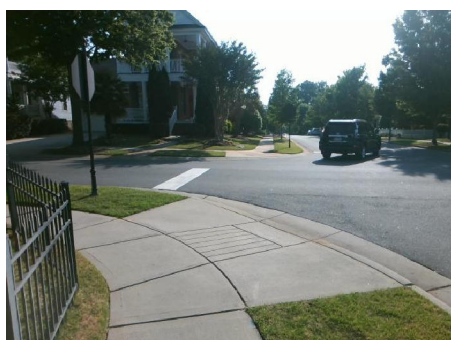
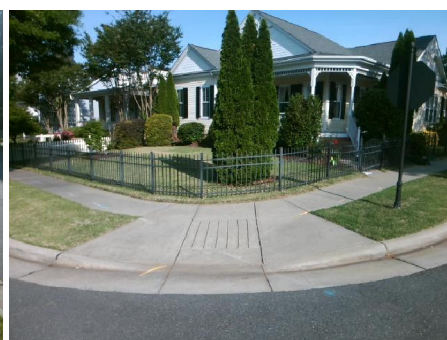
**LT RP < 5%**

**Not Found, R304.5.1, R304.2.2, R304.5.3, R304.3.2**

| Compliance | Description | Data | Compliance | Description | Data |
|---|---|---|---|---|---|
| Yes | Ramp Slope LT (%) | 3.2 | No | Ramp Slope RT (%) | 8.4 |
| No | Ramp XSlope LT (%) | 3.0 | Yes | Ramp XSlope RT (%) | 1.9 |
| N/A | Ramp Length (in) | 73.0 | No | Ramp Slope (%) | 8.4 |
| No | Ramp Width (in) | 47.0 | No | Ramp XSlope (%) | 4.4 |

**Remove & Replace Curb Ramp With Two New Directional Ramps or Equivalent.**
