Access Compliance Report

Public Rights-of-Way

(Curb Ramps)

Intersection ID: 45177	Main Street: ELDON_DR	Cross Street: GARLAND_CT	Location: SW
ADA ID: 501BE9E61FB1	Ramp Type: PerpDiag	Initial Pass/Fail: Fail	Overall Compliance: No
Severity Score: 12.5			
Codes/Mitigation Info/Possible Solution		Field Measurements/Component Compliance

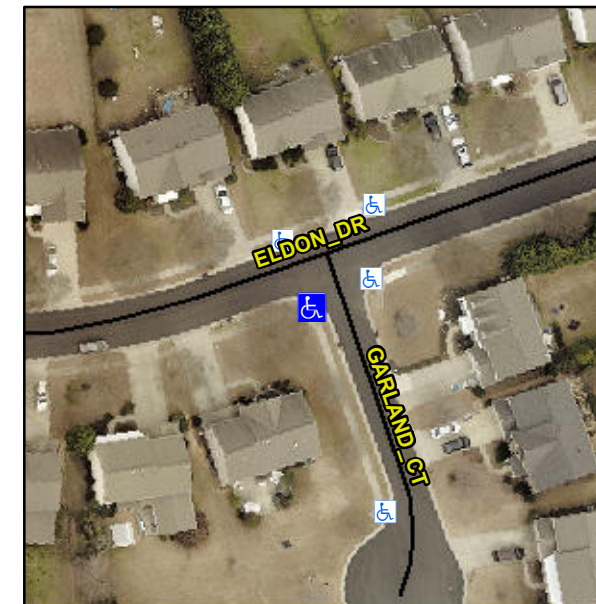
Not Found, R304.5.3

Compliance	Description	Data	Compliance	Description	Data
N/A	Ramp Length (in)	46.5	Yes	Ramp Slope (%)	6.8
Yes	Ramp Width (in)	59.0	No	Ramp XSlope (%)	5.3
N/A	Flare Type LT	N/A	N/A	Flare Type RT	N/A
N/A	Flare Slope LT (%)	N/A	N/A	Flare Slope RT (%)	N/A
N/A	Flare Traversable LT?	N/A	N/A	Flare Traversable RT?	N/A
N/A	Landing Length (in)	N/A	N/A	DWS Provided?	N/A
N/A	Landing Width (in)	N/A	N/A	DWS Contrast?	N/A
N/A	Landing Slope (%)	N/A	N/A	DWS Length (in)	N/A
N/A	Landing X Slope (%)	N/A	N/A	DWS Full Width?	N/A
N/A	Landing Curb? (Y/N)	N/A	N/A	DWS Offset (in)	N/A
N/A	Shared Landing?	N/A			
N/A	Gutter Ponding?	N/A	N/A	Gutter Slope (%)	N/A
N/A	Gutter Lip Ht (in)	N/A	N/A	Gutter X Slope (%)	N/A
N/A	Painted X Walk1?	No	N/A	Painted X Walk2?	No
	X Walk 1 Direction	To E		X Walk 2 Direction	To N
N/A	X Walk 1 Width (in)	N/A	N/A	X Walk 2 Width (in)	N/A
	X Walk 1 Slope (%)	4.2		X Walk 2 Slope (%)	0.5
	X Walk 1 X Slope (%)	2.3		X Walk 2 X Slope (%)	3.6

N/A	Ramp inside XWalk1?	N/A	N/A	Ramp inside XWalk2?	N/A
	Road Slope (%)	4.2	N/A	Clear Space?	N/A
	Road X Slope (%)	3.6	N/A	Clear Space to XWalk (in)	N/A
N/A	Any Obstructions?	N/A	N/A	Storm Grate/Utility Hazard?	N/A
	Obstruction Type			Storm Grate/Utility Type	
		N/A			N/A
		Yes		Surface Condition? (G/P)	Good

Remove & Replace Curb Ramp With Two New Directional Ramps or Equivalent.
