# Access Compliance Report

## Public Rights-of-Way

### (Curb Ramps)

| Intersection ID: 10292 | Main Street: BEATTIES_FORD_RD | Cross Street: DIXON_ST | Location: NW |

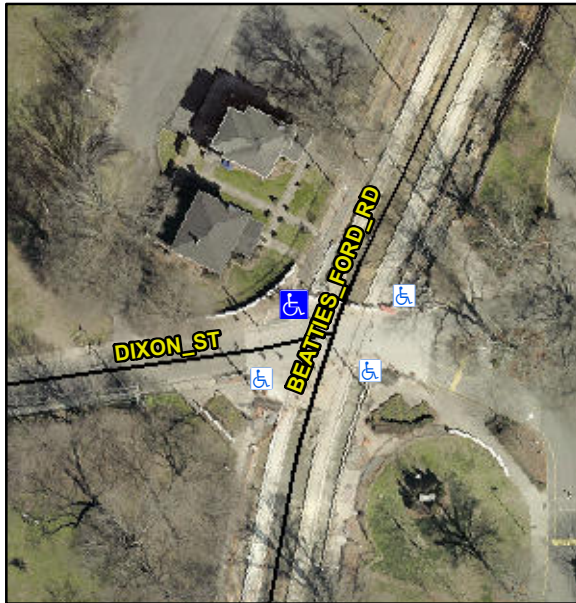
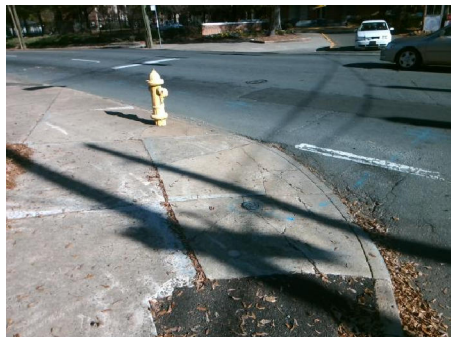
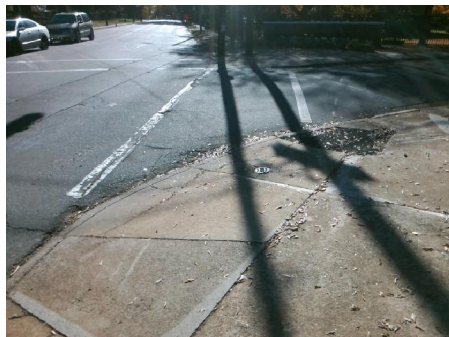
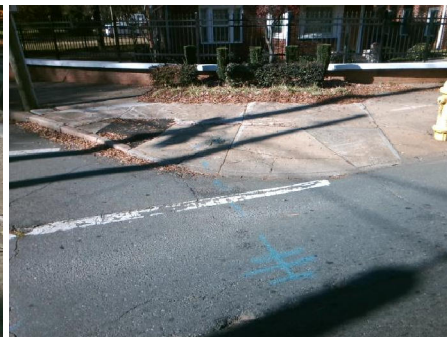
**Not Found, R304.2.2, R302.7**

| Compliance | Description | Data | Compliance | Description | Data |
|---|---|---|---|---|---|
| N/A | Ramp Length (in) | 68.0 | No | Ramp Slope (%) | 15.1 |
| | | No | | Surface Condition? (G/P) | Poor |

**Remove & Replace Curb Ramp With Two New Directional Ramps or Equivalent.**
