# Access Compliance Report

## Public Rights-of-Way

| Intersection ID: 15293 | Main Street: ARDSLEY_RD | Cross Street: QUEENS_RD | Location: NE |
| ADA ID: 508AB1237295 | Ramp Type: Perp | Initial Pass/Fail: Fail | Overall Compliance: No |

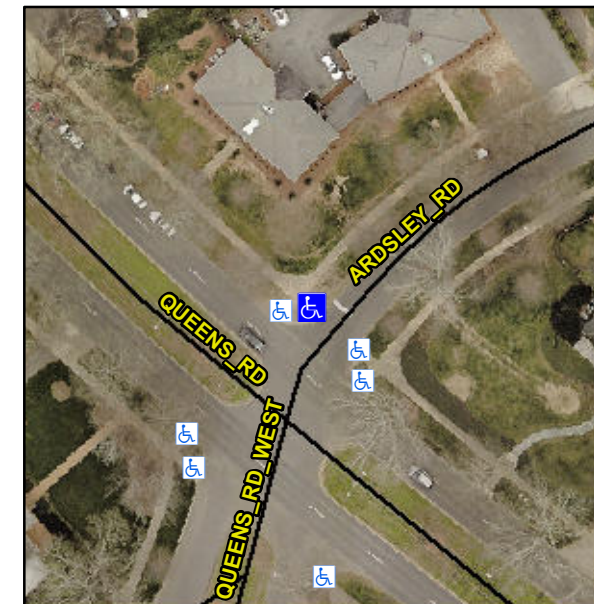
| Severity Score: 13.75 | | | |

**R304.2.2, R304.5.3**

| Compliance | Description | Data | Compliance | Description | Data |
|---|---|---|---|---|---|
| N/A | Ramp Length (in) | 83.0 | No | Ramp Slope (%) | 8.5 |
| Yes | Ramp Width (in) | 61.0 | No | Ramp XSlope (%) | 3.9 |

**Remove & Replace Entire Ramp.**

Total Cost: \$ 1850.00
