# Access Compliance Report

## Public Rights-of-Way

### (Curb Ramps)

| Intersection ID: 24953 | Main Street: BENRIDGE_LN | Cross Street: MACANDREW_DR | Location: SW |

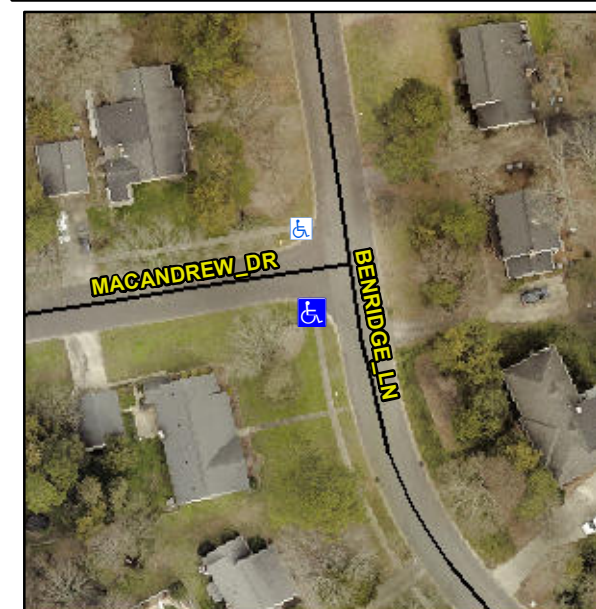
| ADA ID: 50A4AC8FCB3B | Ramp Type: PerpDiag | Initial Pass/Fail: Fail | Overall Compliance: No |

**Not Found, R304.2.2, R304.5.3**

| Compliance | Description | Data | Compliance | Description | Data |
|---|---|---|---|---|---|
| N/A | Ramp Length (in) | 30.0 | No | Ramp Slope (%) | 9.5 |
| Yes | Ramp Width (in) | 48.0 | No | Ramp XSlope (%) | 2.1 |

**Remove & Replace Curb Ramp With Two New Directional Ramps or Equivalent.**
