Access Compliance Report Public Rights-of-Way (Curb Ramps)

Intersection ID: 12164 Main Street: SEIGLE_AV Cross Street: BELMONT_AV Location: E

ADA ID: 5100D2692A29 Ramp Type: Perp Initial Pass/Fail: Fail Overall Compliance: No Severity Score: 25

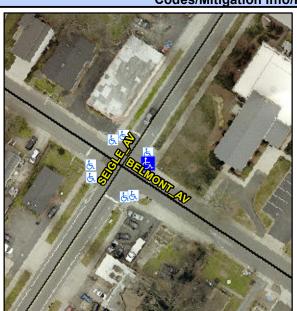
rield Measurements/Component Compilance					
Compliance Description		Data	Compliance Description		Data
N/A	Ramp Length (in)	43.0	Yes	Ramp Slope (%)	5.4
Yes	Ramp Width (in)	48.0	No	Ramp XSlope (%)	7.2
N/A	Flare Type LT	N/A	N/A	Flare Type RT	N/A
N/A	Flare Slope LT (%)	N/A	N/A	Flare Slope RT (%)	N/A
N/A	Flare Traversable LT?	N/A	N/A	Flare Traversable RT?	N/A
N/A	Landing Length (in)	N/A	N/A	DWS Provided?	N/A
N/A	Landing Width (in)	N/A	N/A	DWS Contrast?	N/A
N/A	Landing Slope (%)	N/A	N/A	DWS Length (in)	N/A
N/A	Landing X Slope (%)	N/A	N/A	DWS Full Width?	N/A
N/A	Landing Curb? (Y/N)	N/A	N/A	DWS Offset (in)	N/A
N/A	Shared Landing?	N/A			
N/A	Gutter Ponding?	N/A	N/A	Gutter Slope (%)	N/A
N/A	Gutter Lip Ht (in)	N/A	N/A	Gutter X Slope (%)	N/A
N/A	Painted X Walk1?	No	N/A	Painted X Walk2?	N/A
	X Walk 1 Direction	To SW		X Walk 2 Direction	N/A
N/A	X Walk 1 Width (in)	N/A	N/A	X Walk 2 Width (in)	N/A
	X Walk 1 Slope (%)	2.8		X Walk 2 Slope (%)	N/A

X Walk 1 X Slope (%)	6.7		X Walk 2 X Slope (%)	N/A
N/A	Ramp inside XWalk1?	N/A	N/A	Ramp inside XWalk2?	N/A
	Road Slope (%)	N/A	N/A	Clear Space?	N/A
	Road X Slope (%)	N/A	N/A	Clear Space to XWalk (in)	N/A
N/A	Any Obstructions?	N/A	N/A	Storm Grate/Utility Hazard?	N/A
	Obstruction Type			Storm Grate/Utility Type

Remove & Replace Entire Ramp.

R304.5.3
