Access Compliance Report

Public Rights-of-Way

(Curb Ramps)

Intersection ID: 11330	Main Street: FLAMINGO_AV	Cross Street: PALM_AV	Location: SE
ADA ID: 5128FC1A0A76	Ramp Type: Perp	Initial Pass/Fail: Fail	Overall Compliance: No
Codes/Mitigation Info/Possible Solution		Field Measurements/Component Compliance	
Severity Score: 21.25

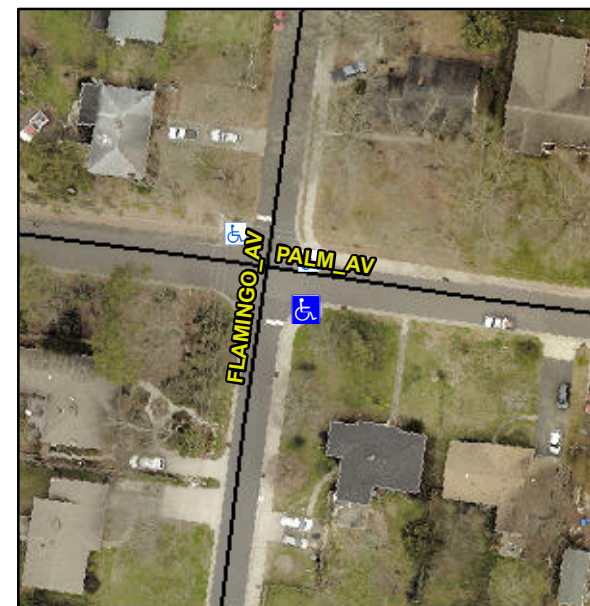
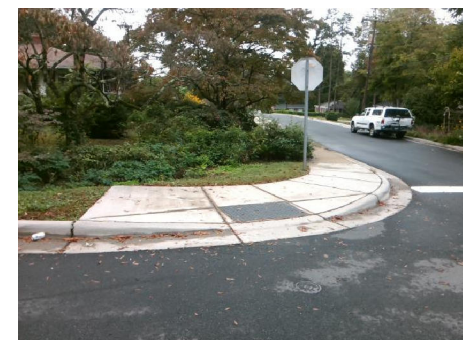
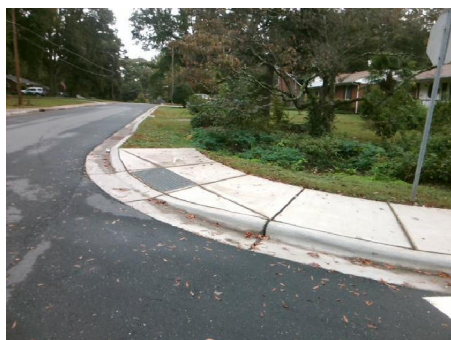
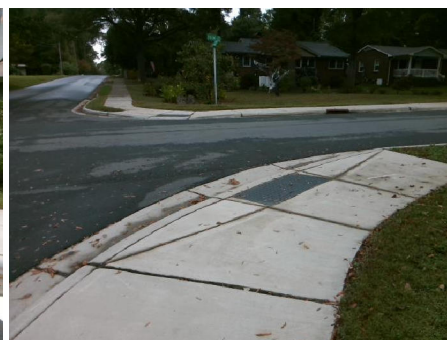
Not Found, R304.5.1, R304.5.3

Compliance	Description	Data	Compliance	Description	Data
N/A	Ramp Length (in)	67.5	Yes	Ramp Slope (%)	5.6
No	Ramp Width (in)	40.0	No	Ramp XSlope (%)	6.9
N/A	Flare Type LT	N/A	N/A	Flare Type RT	N/A
N/A	Flare Slope LT (%)	N/A	N/A	Flare Slope RT (%)	N/A
N/A	Flare Traversable LT?	N/A	N/A	Flare Traversable RT?	N/A
N/A	Landing Length (in)	N/A	N/A	DWS Provided?	N/A
N/A	Landing Width (in)	N/A	N/A	DWS Contrast?	N/A
N/A	Landing Slope (%)	N/A	N/A	DWS Length (in)	N/A
N/A	Landing X Slope (%)	N/A	N/A	DWS Full Width?	N/A
N/A	Landing Curb? (Y/N)	N/A	N/A	DWS Offset (in)	N/A
N/A	Shared Landing?	N/A			
N/A	Gutter Ponding?	N/A	N/A	Gutter Slope (%)	N/A
N/A	Gutter Lip Ht (in)	N/A	N/A	Gutter X Slope (%)	N/A
N/A	Painted X Walk1?	No	N/A	Painted X Walk2?	N/A
	X Walk 1 Direction	To N		X Walk 2 Direction	N/A
N/A	X Walk 1 Width (in)	N/A	N/A	X Walk 2 Width (in)	N/A
	X Walk 1 Slope (%)	5.0		X Walk 2 Slope (%)	N/A
	X Walk 1 X Slope (%)	4.0		X Walk 2 X Slope (%)	N/A

N/A	Ramp inside XWalk1?	N/A	N/A	Ramp inside XWalk2?	N/A
	Road Slope (%)	N/A	N/A	Clear Space?	N/A
	Road X Slope (%)	N/A	N/A	Clear Space to XWalk (in)	N/A
N/A	Any Obstructions?	N/A	N/A	Storm Grate/Utility Hazard?	N/A
	Obstruction Type			Storm Grate/Utility Type	
		N/A			N/A
			Yes	Surface Condition? (G/P)	Good

Remove & Replace Entire Ramp.
