Access Compliance Report

Public Rights-of-Way

(Curb Ramps)

Intersection ID: N/A		Main Street: SHASTA_LN		Cross Street: SUNBURY_LN		Location: S			
ADA ID: 515E12DCD396		Ramp Type: Directional1		Initial Pass/Fail: Fail		Overall Compliance: No		Severity Score: 1.25	
Codes/Mitigation Info/Possible Solution				Field Measurements/Component Compliance					
<div>

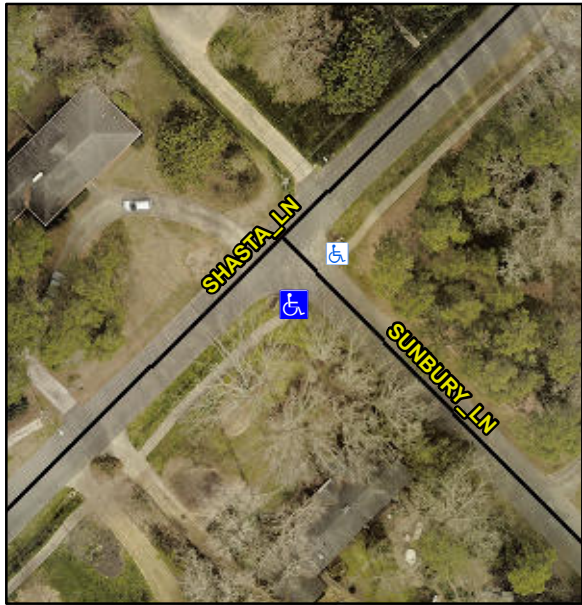
No	Ramp XSlope (%)	2.9			
				N/A	Flare Type LT	N/A	N/A	Flare Type RT	N/A
				N/A	Flare Slope LT (%)	N/A	N/A	Flare Slope RT (%)	0.0
				N/A	Flare Traversable LT?	N/A	N/A	Flare Traversable RT?	N/A
				N/A	Landing Length (in)	0.0	N/A	DWS Provided?	N/A
				N/A	Landing Width (in)	0.0	N/A	DWS Contrast?	N/A
				N/A	Landing Slope (%)	0.0	N/A	DWS Length (in)	N/A
				N/A	Landing X Slope (%)	0.0	N/A	DWS Full Width?	N/A
				N/A	Landing Curb? (Y/N)	N/A	N/A	DWS Offset LT (in)	N/A
				N/A	Shared Landing?	N/A	N/A	DWS Offset RT (in)	N/A
				N/A	Gutter Ponding?	0.0	N/A	Gutter Slope (%)	N/A
				N/A	Gutter Lip Ht (in)	0.0	N/A	Gutter X Slope (%)	N/A
				N/A	Painted X Walk1?	No		Road Slope (%)	4.2
					X Walk 1 Direction	To NE		Road X Slope (%)	2.1
					X Walk 1 Width (in)	N/A		Clear Space?	N/A
					X Walk 1 Slope (%)	4.2	N/A	Clear Space to XWalk (in)	N/A
					X Walk 1 X Slope (%)	2.1	N/A	Storm Grate/Utility Hazard?	N/A
				N/A	Ramp inside XWalk1?	N/A		Storm Grate/Utility Type

N/A	Any Obstructions?	N/A			N/A
					Obstruction Type		Yes	Surface Condition? (G/P)	Good
							N/A	Curb Slope (%)	3.1

</div> <div>Possible Solutions:</div> <div>Remove & Replace Entire Ramp.</div> <div>Surveyor Notes:</div> <div>N/A</div> <div>PROW/ADA:</div> <div>R304.5.3</div> <div>Street 1 Name</div> <div>SUNBURY LN</div> <div>Stop Condition-Street 1</div> <div>StopSign</div> <div>Street 2 Name</div> <div>N/A</div> <div>Stop Condition-Street 2</div> <div>N/A</div> <div>Total Cost:</div> <div>\$</div> <div>1600.00</div>				Compliance	Description	Data	Compliance	Description	Data
				N/A	Ramp Length (in)	74.0	N/A	Grade Break?	N/A
				Yes	Ramp Width (in)	60.0	N/A	Grade Break Slope (%)	0.0
				Yes	Ramp Slope (%)	1.8	N/A	Grade Break XSlope (%)	0.0
