## Access Compliance Report Public Rights-of-Way (Curb Ramps)

Intersection ID: 12302 Main Street: SALAMANDER\_CT Cross Street: TIGER\_LILY\_LN Location: NW

ADA ID: 516EBBF18B2B Ramp Type: PerpDiag Initial Pass/Fail: Fail Overall Compliance: No Severity Score: 21.25

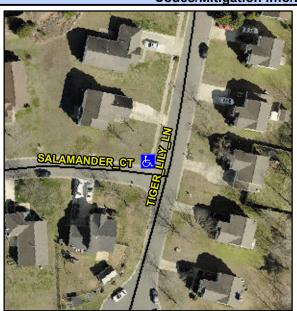
Not Found, R304.5.1, R304.2.2

| Field Measurements/Component Compliance | | | | | |
|---|---|---|---|---|---|
| N/A | Ramp Length (in) | 48.0 | No | Ramp Slope (%) | 11.3 |
| No | Ramp Width (in) | 38.5 | Yes | Ramp XSlope (%) | 0.8 |

SALAMANDER CT StopSign TIGER LILY LN None Possible Solutions:

Remove & Replace Curb Ramp With
Two New Directional Ramps or
Equivalent.
