Access Compliance Report

Public Rights-of-Way

(Curb Ramps)

Intersection ID: 8871	Main Street: NORRIS_AV	Cross Street: ISENHOUR_ST	Location: NE
ADA ID: 5197E38AA6C3	Ramp Type: Perp	Initial Pass/Fail: Fail	Overall Compliance: No
Severity Score: 10			
Codes/Mitigation Info/Possible Solution		Field Measurements/Component Compliance

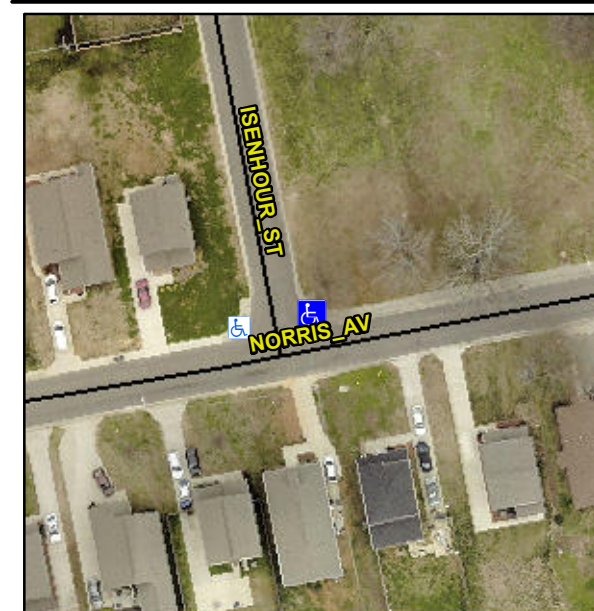
Not Found, R304.5.1, R304.5.3

Compliance	Description	Data	Compliance	Description	Data
N/A	Ramp Length (in)	25.0	Yes	Ramp Slope (%)	6.1
No	Ramp Width (in)	46.0	No	Ramp XSlope (%)	2.3
N/A	Flare Type LT	N/A	N/A	Flare Type RT	N/A
N/A	Flare Slope LT (%)	N/A	N/A	Flare Slope RT (%)	N/A
N/A	Flare Traversable LT?	N/A	N/A	Flare Traversable RT?	N/A
N/A	Landing Length (in)	N/A	N/A	DWS Provided?	N/A
N/A	Landing Width (in)	N/A	N/A	DWS Contrast?	N/A
N/A	Landing Slope (%)	N/A	N/A	DWS Length (in)	N/A
N/A	Landing X Slope (%)	N/A	N/A	DWS Full Width?	N/A
N/A	Landing Curb? (Y/N)	N/A	N/A	DWS Offset (in)	N/A
N/A	Shared Landing?	N/A			
N/A	Gutter Ponding?	N/A	N/A	Gutter Slope (%)	N/A
N/A	Gutter Lip Ht (in)	1.0	N/A	Gutter X Slope (%)	N/A
N/A	Painted X Walk1?	No	N/A	Painted X Walk2?	N/A
	X Walk 1 Direction	To W		X Walk 2 Direction	N/A
N/A	X Walk 1 Width (in)	N/A	N/A	X Walk 2 Width (in)	N/A
	X Walk 1 Slope (%)	3.5		X Walk 2 Slope (%)	N/A
	X Walk 1 X Slope (%)	1.3		X Walk 2 X Slope (%)	N/A

Remove & Replace Entire Ramp.

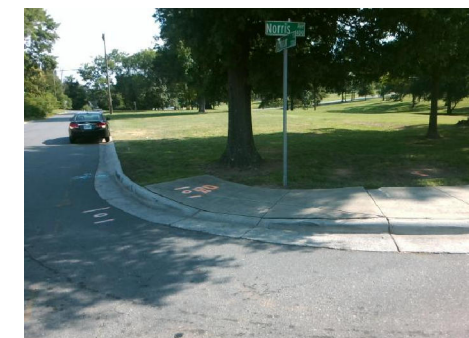
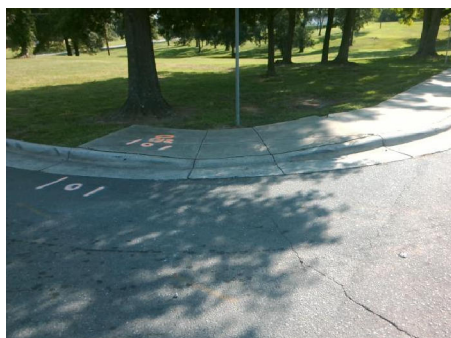
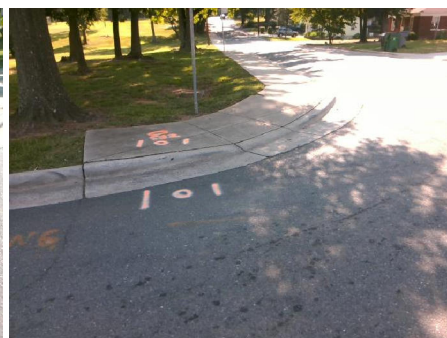
N/A	Ramp inside XWalk1?	N/A	N/A	Ramp inside XWalk2?	N/A
	Road Slope (%)	N/A	N/A	Clear Space?	N/A
	Road X Slope (%)	N/A	N/A	Clear Space to XWalk (in)	N/A
N/A	Any Obstructions?	N/A	N/A	Storm Grate/Utility Hazard?	N/A
	Obstruction Type			Storm Grate/Utility Type	
		N/A			N/A
		Yes		Surface Condition? (G/P)	Good
