## **Access Compliance Report Public Rights-of-Way** (Curb Ramps)

Intersection ID: 4249 Main Street: N\_TRYON\_ST Cross Street: PAVILION\_BV Location: NW ADA ID: 51EBF7081C92 Ramp Type: Perp Initial Pass/Fail: Fail **Overall Compliance: No** Severity Score: 21.25

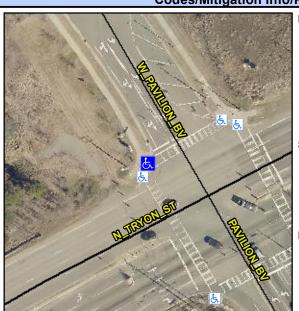
| Field Measurements/Component Compliance | | | | | |
|---|---|---|---|---|---|
| No | Ramp Width (in) | 44.0 | No | Ramp XSlope (%) | 5.7 |

**PAVILION BV** Street 1 Name Stop Condition-Street 2 Signal Street 2 Name N/A Stop Condition-Street 1 N/A Possible Solutions: Remove & Replace Entire Ramp. Surveyor Notes: N/A PROW/ADA: Not Found, R304.5.1, R304.5.3
