# Access Compliance Report

## Public Rights-of-Way

### (Curb Ramps)

Intersection ID: 16207	Main Street: MONROE_RD	Cross Street: COMMODORE_ST	Location: SW
ADA ID: 51F20A6C0A47	Ramp Type: Combination1Diag	Initial Pass/Fail: Fail	Overall Compliance: No
		Severity Score: 0

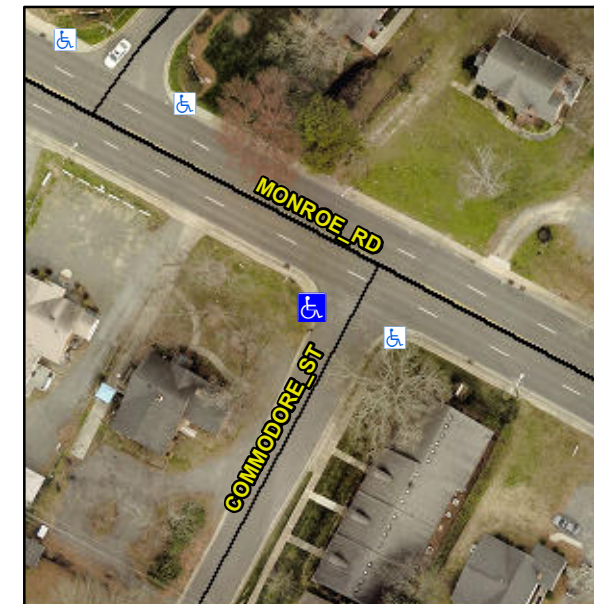
**Not Found, R304.5.1, R304.3.2**

Compliance	Description	Data	Compliance	Description	Data
N/A	Ramp Length LT (in)	51.0	N/A	Ramp Length RT (in)	53.0
No	Ramp Width LT (in)	36.0	No	Ramp Width RT (in)	36.0
Yes	Ramp Slope LT (%)	7.8	No	Ramp Slope RT (%)	10.2
Yes	Ramp XSlope LT (%)	1.1	Yes	Ramp XSlope RT (%)	0.9
N/A	Ramp Length (in)	25.0	Yes	Ramp Slope (%)	6.3
Yes	Ramp Width (in)	48.0	Yes	Ramp XSlope (%)	1.0
N/A	Flare Type LT	N/A	N/A	Flare Type RT	N/A
N/A	Flare Slope LT (%)	N/A	N/A	Flare Slope RT (%)	N/A
N/A	Flare Traversable LT?	N/A	N/A	Flare Traversable RT?	N/A
N/A	Landing Length (in)	N/A	N/A	DWS Provided?	N/A
N/A	Landing Width (in)	N/A	N/A	DWS Contrast?	N/A
N/A	Landing Slope (%)	N/A	N/A	DWS Length (in)	N/A
N/A	Landing X Slope (%)	N/A	N/A	DWS Full Width?	N/A
N/A	Landing Curb? (Y/N)	N/A	N/A	DWS Offset (in)	N/A
N/A	Shared Landing?	N/A			
N/A	Gutter Ponding?	N/A	N/A	Gutter Slope (%)	N/A
N/A	Gutter Lip Ht (in)	N/A	N/A	Gutter X Slope (%)	N/A
N/A	Painted X Walk1?	No	N/A	Painted X Walk2?	No

**Remove & Replace Curb Ramp With Two New Directional Ramps or Equivalent.**
