| Intersection ID: 28287 | Main Street: BRANDON_BROOK_DR | Cross Street: OLD_ARDREY_KELL_RD | Location: | SE |
| ADA ID: 525A61025305 | Ramp Type: Perp | Initial Pass/Fail: Fail | Overall Compliance: No | Severity Score: 37.5 |

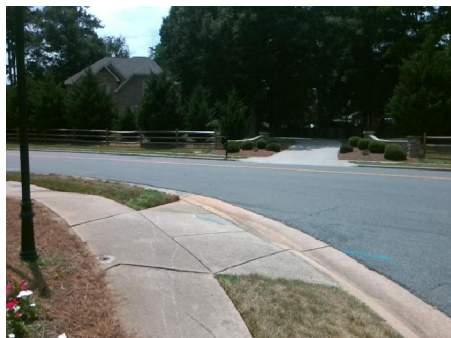
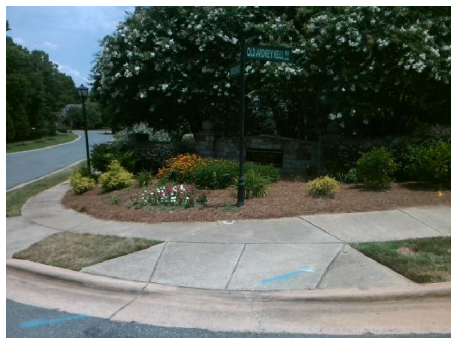
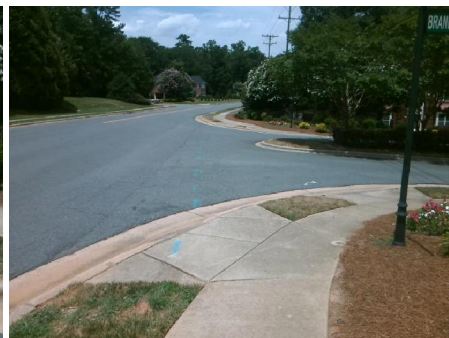
Not Found, R304.2.2, R304.5.3

| Possible Solutions: | | | Compliance | Description | Data | Compliance | Description | Data |
|--|--|--|---|---|---|---|---|---|
| Remove & Replace Entire Ramp. | | | N/A | Ramp Length (in) | 94.0 | No | Ramp Slope (%) | 9.1 |
| | | | Yes | Ramp Width (in) | 48.0 | No | Ramp XSlope (%) | 8.8 |

Remove & Replace Entire Ramp.
