Access Compliance Report

Public Rights-of-Way

(Curb Ramps)

Intersection ID: 28067	Main Street: LANDEN_DR	Cross Street: SOUTH_BEND_LN	Location: NE
ADA ID: 52E12A860FA9	Ramp Type: PerpDiag	Initial Pass/Fail: Fail	Overall Compliance: No
Severity Score: 21.25			
Codes/Mitigation Info/Possible Solution		Field Measurements/Component Compliance

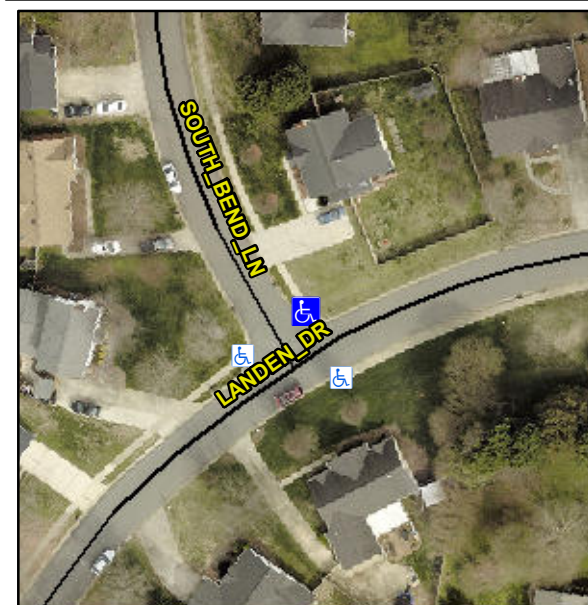
Not Found, R304.5.1, R304.2.2

Compliance	Description	Data	Compliance	Description	Data
N/A	Ramp Length (in)	56.0	No	Ramp Slope (%)	9.0
No	Ramp Width (in)	40.0	Yes	Ramp XSlope (%)	1.6
N/A	Flare Type LT	N/A	N/A	Flare Type RT	N/A
N/A	Flare Slope LT (%)	N/A	N/A	Flare Slope RT (%)	N/A
N/A	Flare Traversable LT?	N/A	N/A	Flare Traversable RT?	N/A
N/A	Landing Length (in)	N/A	N/A	DWS Provided?	N/A
N/A	Landing Width (in)	N/A	N/A	DWS Contrast?	N/A
N/A	Landing Slope (%)	N/A	N/A	DWS Length (in)	N/A
N/A	Landing X Slope (%)	N/A	N/A	DWS Full Width?	N/A
N/A	Landing Curb? (Y/N)	N/A	N/A	DWS Offset (in)	N/A
N/A	Shared Landing?	N/A			
N/A	Gutter Ponding?	N/A	N/A	Gutter Slope (%)	N/A
N/A	Gutter Lip Ht (in)	N/A	N/A	Gutter X Slope (%)	N/A
N/A	Painted X Walk1?	No	N/A	Painted X Walk2?	No
	X Walk 1 Direction	To SW		X Walk 2 Direction	To SE
N/A	X Walk 1 Width (in)	N/A	N/A	X Walk 2 Width (in)	N/A
	X Walk 1 Slope (%)	2.8		X Walk 2 Slope (%)	3.5
	X Walk 1 X Slope (%)	1.9		X Walk 2 X Slope (%)	1.1

Remove & Replace Curb Ramp With Two New Directional Ramps or Equivalent.
