Access Compliance Report

Public Rights-of-Way

(Curb Ramps)

Intersection ID: 17819	Main Street: LYTTLETON_DR	Cross Street: N_SHARON_AMITY_RD	Location: SW
ADA ID: 536D9C25B8BA	Ramp Type: ParaDiag	Initial Pass/Fail: Fail	Overall Compliance: No
			Severity Score: 13.75

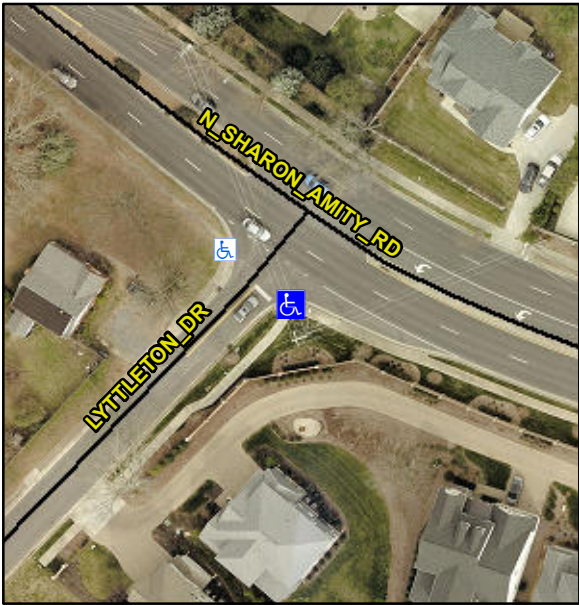
Surveyor Notes: CURB LIP 1.0			N/A	Shared Landing?	N/A				
PROW/ADA: R304.3.2, R304.5.3			N/A	Gutter Ponding?	N/A	N/A	Gutter Slope (%)	N/A	
			N/A	Gutter Lip Ht (in)	N/A	N/A	Gutter X Slope (%)	N/A	
			N/A	Painted X Walk1?	No	N/A	Painted X Walk2?	No	
				X Walk 1 Direction	To NE		X Walk 2 Direction	To NW	
			N/A	X Walk 1 Width (in)	N/A	N/A	X Walk 2 Width (in)	N/A	
				X Walk 1 Slope (%)	2.8		X Walk 2 Slope (%)	0.1	
				X Walk 1 X Slope (%)	1.5		X Walk 2 X Slope (%)	0.0	
			N/A	Ramp inside XWalk1?	N/A	N/A	Ramp inside XWalk2?	N/A	
				Road Slope (%)	0.3	N/A	Clear Space?	N/A	
				Road X Slope (%)	0.2	N/A	Clear Space to XWalk (in)	N/A	
			N/A	Any Obstructions?	N/A	N/A	Storm Grate/Utility Hazard?	N/A	
				Obstruction Type			Storm Grate/Utility Type		
Total Cost:			\$	3200.00	N/A			N/A	
						Yes	Surface Condition? (G/P)	Good	
						N/A	Curb Slope (%)	5.9

<div>Street 1 Name<div>N SHARON AMITY RD</div></div> <div>Stop Condition-Street 1<div>None</div></div> <div>Street 2 Name<div>LYTTLETON DR</div></div> <div>Stop Condition-Street 2<div>StopSign</div></div>	Possible Solutions: Remove & Replace Curb Ramp With Two New Directional Ramps or Equivalent.			Compliance	Description	Data	Compliance	Description	Data
				N/A	Ramp Length LT (in)	54.0	N/A	Ramp Length RT (in)	52.0
				Yes	Ramp Width LT (in)	60.0	Yes	Ramp Width RT (in)	60.5
				No	Ramp Slope LT (%)	11.5	Yes	Ramp Slope RT (%)	7.6
				No	Ramp XSlope LT (%)	3.0	No	Ramp XSlope RT (%)	2.1
				N/A	Landing Length (in)	N/A	N/A	DWS Provided?	N/A
				N/A	Landing Width (in)	N/A	N/A	DWS Contrast?	N/A
				N/A	Landing Slope (%)	N/A	N/A	DWS Length (in)	N/A
				N/A	Landing X Slope (%)	N/A	N/A	DWS Full Width?	N/A
				N/A	Landing Curb? (Y/N)	N/A	N/A	DWS Offset (in)	N/A
