Access Compliance Report

Public Rights-of-Way

(Curb Ramps)

Intersection ID: 53270	Main Street: MONROE_RD	Cross Street: MERIDIAN_CENTER_DR	Location: N
ADA ID: 53BCD5EFABE9	Ramp Type: Directional1	Initial Pass/Fail: Fail	Overall Compliance: No
Codes/Mitigation Info/Possible Solution		Field Measurements/Component Compliance	
Severity Score: 13.75

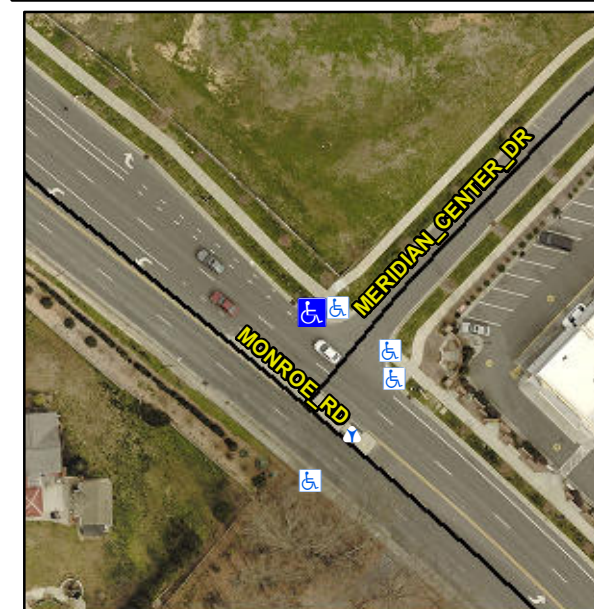
PROW/ADA:

R304.2.2, R304.5.3

Compliance	Description	Data	Compliance	Description	Data
N/A	Ramp Length (in)	77.0	N/A	Grade Break?	N/A
Yes	Ramp Width (in)	67.0	N/A	Grade Break Slope (%)	0.0
No	Ramp Slope (%)	10.1	N/A	Grade Break XSlope (%)	0.0
No	Ramp XSlope (%)	3.4			
N/A	Flare Type LT	N/A	N/A	Flare Type RT	N/A
N/A	Flare Slope LT (%)	N/A	N/A	Flare Slope RT (%)	0.0
N/A	Flare Traversable LT?	N/A	N/A	Flare Traversable RT?	N/A
N/A	Landing Length (in)	0.0	N/A	DWS Provided?	N/A
N/A	Landing Width (in)	0.0	N/A	DWS Contrast?	N/A
N/A	Landing Slope (%)	0.0	N/A	DWS Length (in)	N/A
N/A	Landing X Slope (%)	0.0	N/A	DWS Full Width?	N/A
N/A	Landing Curb? (Y/N)	N/A	N/A	DWS Offset LT (in)	N/A
N/A	Shared Landing?	N/A	N/A	DWS Offset RT (in)	N/A
N/A	Gutter Ponding?	0.0	N/A	Gutter Slope (%)	N/A
N/A	Gutter Lip Ht (in)	0.0	N/A	Gutter X Slope (%)	N/A
N/A	Painted X Walk1?	No		Road Slope (%)	0.7
	X Walk 1 Direction	To SW		Road X Slope (%)	1.0
	X Walk 1 Width (in)	N/A		Clear Space?	N/A

X Walk 1 Slope (%)	0.7	N/A	Clear Space to XWalk (in)	N/A
	X Walk 1 X Slope (%)	1.0	N/A	Storm Grate/Utility Hazard?	N/A
N/A	Ramp inside XWalk1?	N/A		Storm Grate/Utility Type	
N/A	Any Obstructions?	N/A			N/A
	Obstruction Type		Yes	Surface Condition? (G/P)	Good
			N/A	Curb Slope (%)	7.7

Possible Solutions:

Remove & Replace Entire Ramp.
