## Access Compliance Report Public Rights-of-Way (Curb Ramps)

Intersection ID: 19520 Main Street: SARDIS\_RD Cross Street: TIMBER\_LN Location: SE

ADA ID: 547BBD273522 Ramp Type: Perp Initial Pass/Fail: Fail Overall Compliance: No Severity Score: 25

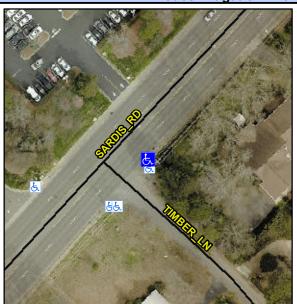
Possible Solutions:	<u>c</u>
Remove & Replace Entire Ramp.	N
·	Υ
	N
	N
	N
	N
Surveyor Notes:	N
N/A	N
	N
	N
	N
PROW/ADA:	N
Not Found, R304.2.2, R304.5.3	N
	N
	N

Field Measurements/Component Compliance							
Comp	liance Description	Data	Comp	oliance Description	Data		
N/A	Ramp Length (in)	60.0	No	Ramp Slope (%)	10.2		
Yes	Ramp Width (in)	48.0	No	Ramp XSlope (%)	5.1		
N/A	Flare Type LT	N/A	N/A	Flare Type RT	N/A		
N/A	Flare Slope LT (%)	N/A	N/A	Flare Slope RT (%)	N/A		
N/A	Flare Traversable LT?	N/A	N/A	Flare Traversable RT?	N/A		
N/A	Landing Length (in)	N/A	N/A	DWS Provided?	N/A		
N/A	Landing Width (in)	N/A	N/A	DWS Contrast?	N/A		
N/A	Landing Slope (%)	N/A	N/A	DWS Length (in)	N/A		
N/A	Landing X Slope (%)	N/A	N/A	DWS Full Width?	N/A		
N/A	Landing Curb? (Y/N)	N/A	N/A	DWS Offset (in)	N/A		
N/A	Shared Landing?	N/A					
N/A	Gutter Ponding?	N/A	N/A	Gutter Slope (%)	N/A		
N/A	Gutter Lip Ht (in)	N/A	N/A	Gutter X Slope (%)	N/A		
N/A	Painted X Walk1?	No	N/A	Painted X Walk2?	N/A		
	X Walk 1 Direction	To NW		X Walk 2 Direction	N/A		
N/A	X Walk 1 Width (in)	N/A	N/A	X Walk 2 Width (in)	N/A

X Walk 1 Slope (%)	0.6		X Walk 2 Slope (%)	N/A		
	X Walk 1 X Slope (%)	1.5		X Walk 2 X Slope (%)	N/A		
N/A	Ramp inside XWalk1?	N/A	N/A	Ramp inside XWalk2?	N/A		
	Road Slope (%)	N/A	N/A	Clear Space?	N/A		
	Road X Slope (%)	N/A	N/A	Clear Space to XWalk (in)	N/A		
N/A	Any Obstructions?	N/A	N/A	Storm Grate/Utility Hazard?	N/A		
	Obstruction Type			Storm Grate/Utility Type			
		N/A			N/A		
			Yes	Surface Condition? (G/P)	Good		
0			-
