# Access Compliance Report

## Public Rights-of-Way

| Intersection ID: 50618 | Main Street: YELLOW_OAK_RD | Cross Street: ABNEY_CT | Location: | E |
| ADA ID: 5498D8C2F9AB | Ramp Type: Perp | Initial Pass/Fail: Fail | Overall Compliance: No | Severity Score: 25 |

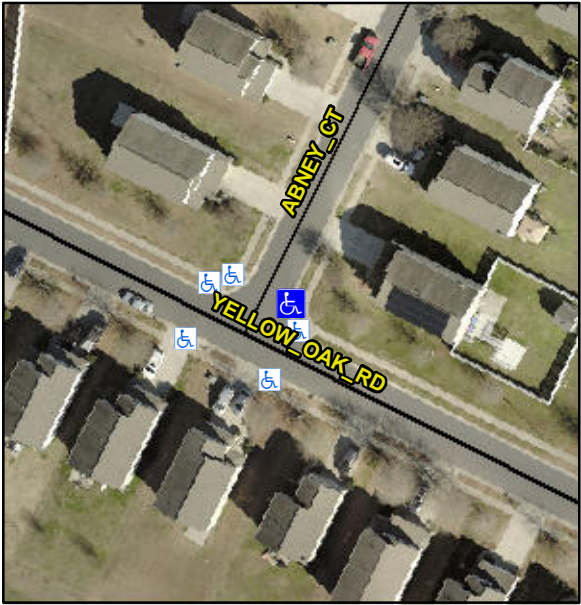
| Codes/Mitigation Info/Possible Solution | | | Field Measurements/Component Compliance | | |
|---|--|---|---|---|---|
| | <b>Remove &amp; Replace Entire Ramp.</b> | | <b>No</b> | Ramp Length (in) | 48.5 |
| <p>Surveyor Notes:</p> <p><b>N/A</b></p> <p>PROW/ADA:</p> <p><b>Not Found, R304.2.2, R304.5.3</b></p> | | | <b>N/A</b> | Flare Type RT | N/A |
