Access Compliance Report

Public Rights-of-Way

(Curb Ramps)

Intersection ID: 15457	Main Street: EAST_BV	Cross Street: LOMBARDY_CR	Location: SW
ADA ID: 5503E6A4B4B8	Ramp Type: Perp	Initial Pass/Fail: Fail	Overall Compliance: No
Severity Score: 35			
Codes/Mitigation Info/Possible Solution		Field Measurements/Component Compliance

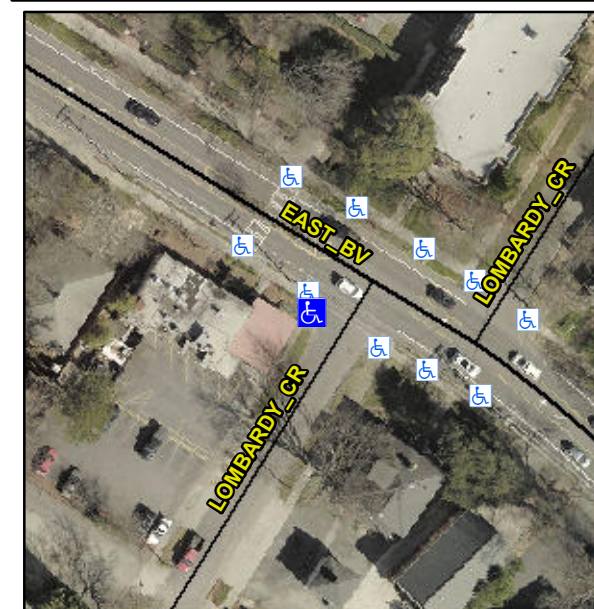
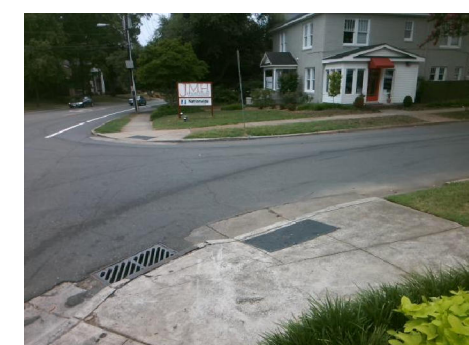
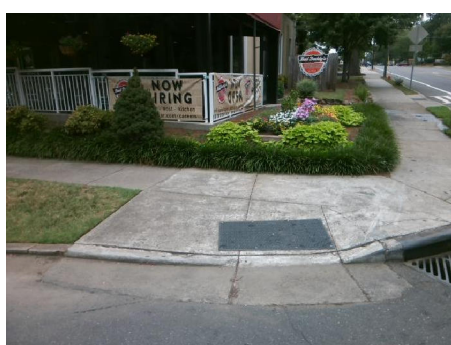
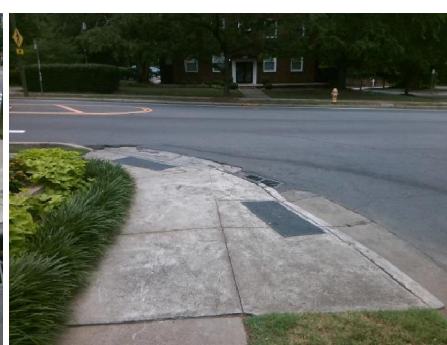
Not Found, R304.5.1, R304.2.2, R304.5.3

Compliance	Description	Data	Compliance	Description	Data
N/A	Ramp Length (in)	40.0	No	Ramp Slope (%)	15.3
No	Ramp Width (in)	37.0	No	Ramp XSlope (%)	3.4
N/A	Flare Type LT	N/A	N/A	Flare Type RT	N/A
N/A	Flare Slope LT (%)	N/A	N/A	Flare Slope RT (%)	N/A
N/A	Flare Traversable LT?	N/A	N/A	Flare Traversable RT?	N/A
N/A	Landing Length (in)	N/A	N/A	DWS Provided?	N/A
N/A	Landing Width (in)	N/A	N/A	DWS Contrast?	N/A
N/A	Landing Slope (%)	N/A	N/A	DWS Length (in)	N/A
N/A	Landing X Slope (%)	N/A	N/A	DWS Full Width?	N/A
N/A	Landing Curb? (Y/N)	N/A	N/A	DWS Offset (in)	N/A
N/A	Shared Landing?	N/A			
N/A	Gutter Ponding?	N/A	N/A	Gutter Slope (%)	N/A
N/A	Gutter Lip Ht (in)	N/A	N/A	Gutter X Slope (%)	N/A
N/A	Painted X Walk1?	No	N/A	Painted X Walk2?	N/A
	X Walk 1 Direction	To SE		X Walk 2 Direction	N/A
N/A	X Walk 1 Width (in)	N/A	N/A	X Walk 2 Width (in)	N/A
	X Walk 1 Slope (%)	2.4		X Walk 2 Slope (%)	N/A
	X Walk 1 X Slope (%)	1.7		X Walk 2 X Slope (%)	N/A

Remove & Replace Entire Ramp.
