# Access Compliance Report

## Public Rights-of-Way

| Intersection ID: 45829 | Main Street: PATRICIA_ANN_LN | Cross Street: CHRISTENBURY_HILLS_LN | Location: NW |
| ADA ID: 5558B55AEB81 | Ramp Type: PerpDiag | Initial Pass/Fail: Fail | Overall Compliance: No |

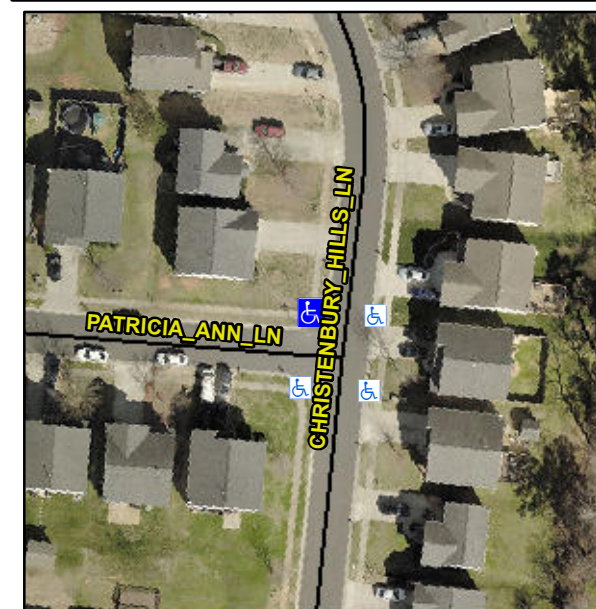
**Not Found, R304.5.1, R304.2.2**

| Compliance | Description | Data | Compliance | Description | Data |
|---|---|---|---|---|---|
| N/A | Ramp Length (in) | 49.0 | No | Ramp Slope (%) | 13.9 |
| No | Ramp Width (in) | 34.0 | Yes | Ramp XSlope (%) | 0.7 |

**Remove & Replace Curb Ramp With Two New Directional Ramps or Equivalent.**
