Access Compliance Report

Public Rights-of-Way

(Curb Ramps)

| Intersection ID: 22517 | Main Street: EL_VERANO_CR | Cross Street: SHARON_LAKES_RD | Location: NW |

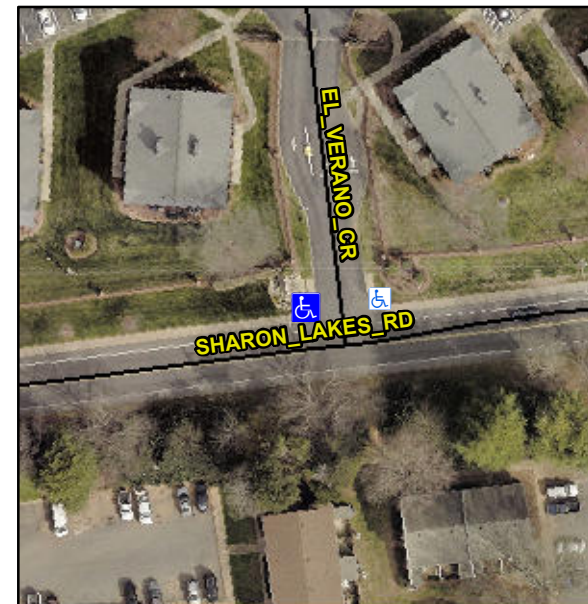
| ADA ID: 558D306C035B | Ramp Type: PerpDiag | Initial Pass/Fail: Fail | Overall Compliance: No |

R304.2.2, R304.5.3

| Compliance | Description | Data | Compliance | Description | Data |
|---|---|---|---|---|---|
| N/A | Ramp Length (in) | 48.0 | No | Ramp Slope (%) | 15.9 |
| Yes | Ramp Width (in) | 48.0 | No | Ramp XSlope (%) | 8.5 |

Remove & Replace Curb Ramp With Two New Directional Ramps or Equivalent.
